# Aircraft Ground Collisions, 2004-2026

Pushback, towing, taxi, jet blast and FOD incidents, and how WheelTug and WheelTug Vision could have helped

October 2026

637 incidents · 2004 – Oct 29, 2026

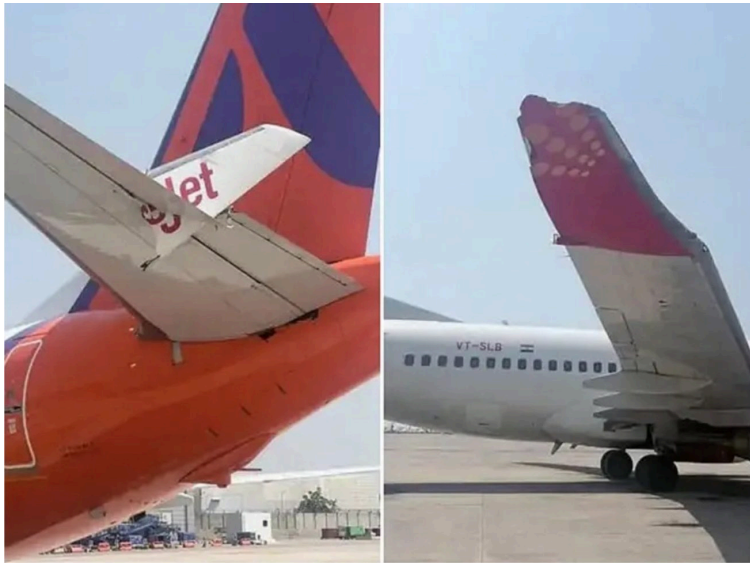
Delhi, 16 Apr 2026: the right winglet of a taxiing SpiceJet 737-700 (VT-SLB) struck the left horizontal stabilizer of an Akasa Air 737 MAX 8 (VT-YBA); the top of the winglet broke off and stayed embedded in the stabilizer (incident [GC-0508](#)). Left: the winglet tip lodged in the Akasa stabilizer; right: SpiceJet's broken winglet. Photos: via [Pune Times Mirror](#).
