# Aircraft Ground Collisions, 2004-2026

Pushback, towing, taxi, jet blast and FOD incidents, and how WheelTug and WheelTug Vision could have helped

October 2026

637 incidents · 2004 – Oct 29, 2026

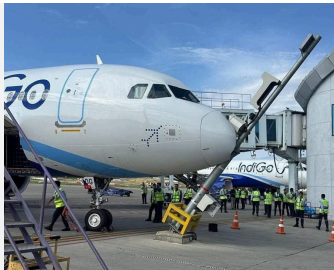
Photo, via @ivancp25 on X — [source](#)

**Our assessment (not an investigator finding):** The crew was steering the aircraft onto its stand and the nose struck the docking-guidance pole. The pole and the stand area just ahead of and below the nose are hard to judge from the flight deck. WheelTug Vision's nose and surroundings cameras would have shown the crew the pole and the remaining clearance, and WheelTug's slow, precise electric drive makes the final metres onto the stand easier to control. If the reported brake failure is confirmed, the cameras would have given earlier warning but could not by themselves have stopped the aircraft.

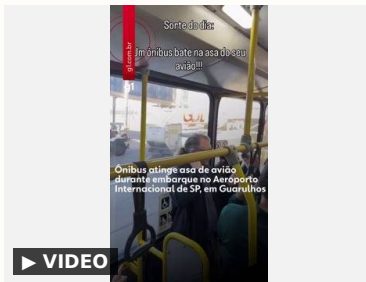
Video posted on X by @g1 (2026-08-20)  
Still: X video preview frame, @g1 on X

**Our assessment (not an investigator finding):** The aircraft was moving under its own (engine) power and the crew misjudged clearance or position. The WheelTug drive alone would not prevent a misjudgement; the relevant element is WheelTug Vision, whose wingtip, nose-gear and surroundings cameras address the fact that pilots cannot see behind or under the aircraft, and even wingtips are not in the normal field of view. Slow, precise electric taxi with engines off also removes jet-blast and engine-ingestion exposure for people nearby.

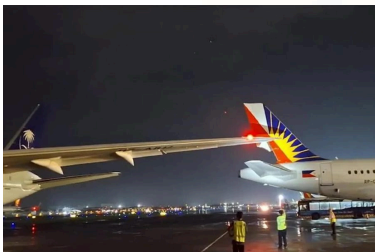
| <b>What happened</b> | Saudi Arabian Airlines flight SV871, a Boeing 787-9 (HZ-AR12), struck the vertical stabilizer of a parked Philippine Airlines A320-214 (RP-C8612), causing severe damage to the A320's rudder. SV871 was taxiing for departure. The A320 was parked at Bay 25. METAR: METAR RPLL 071500Z 23006KT 9999 FEW023CB SCT025 BKN100 26/25 Q1010 NOSIG RMK A2983 CB SW-W METAR RPLL 071600Z 22004KT 180V250 9999 FEW025 SCT100 26/25 Q1009 NOSIG RMK A2980 |

Photo: via ABS-CBN News (abs-cbn.com) — source

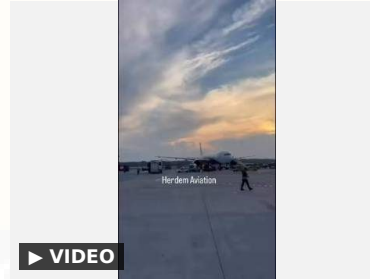
Video posted on X by @muratherdemmm (2026-06-11)  
Still: X video preview frame, @muratherdemmm on X

**Our assessment (not an investigator finding):** The aircraft was moving under its own (engine) power and the crew misjudged clearance or position. The WheelTug drive alone would not prevent a misjudgement; the relevant element is WheelTug Vision, whose wingtip, nose-gear and surroundings cameras address the fact that pilots cannot see behind or under the aircraft, and even wingtips are not in the normal field of view. Slow, precise electric taxi with engines off also removes jet-blast and engine-ingestion exposure for people nearby.

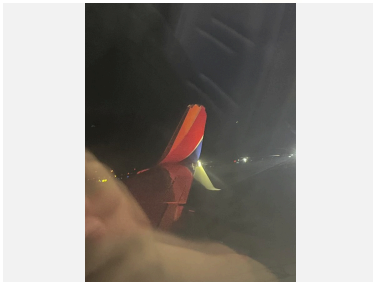
Photo, via @fl360aero on X (match confidence: medium) — [source](#)

**Our assessment (not an investigator finding):** The aircraft was moving under its own (engine) power and the crew misjudged clearance or position. The WheelTug drive alone would not prevent a misjudgement; the relevant element is WheelTug Vision, whose wingtip, nose-gear and surroundings cameras address the fact that pilots cannot see behind or under the aircraft, and even wingtips are not in the normal field of view. Slow, precise electric taxi with engines off also removes jet-blast and engine-ingestion exposure for people nearby.

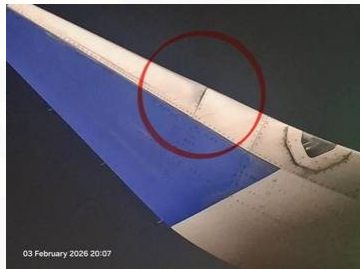
Both aircraft returned to their respective bays for inspection. DGCA officers from the Mumbai office have reached the site.

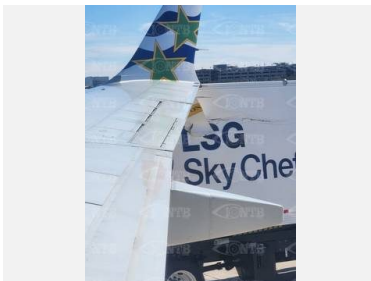
Photo: @IONTB on X — [source](#)

**Our assessment (not an investigator finding):** The aircraft was moving under its own (engine) power and the crew misjudged clearance or position. The WheelTug drive alone would not prevent a misjudgement; the relevant element is WheelTug Vision, whose wingtip, nose-gear and surroundings cameras address the fact that pilots cannot see behind or under the aircraft, and even wingtips are not in the normal field of view. Slow, precise electric taxi with engines off also removes jet-blast and engine-ingestion exposure for people nearby.

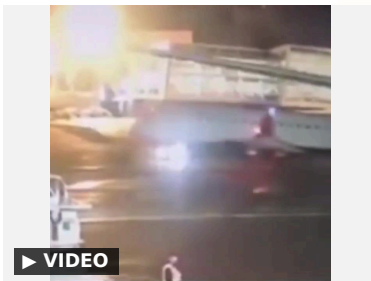
Ramp-incident montage, clip at 1:19  
Still: frame at 1:19. As shared with WheelTug  
(LinkedIn montage, A. G. Giordano)

**Our assessment (not an investigator finding):** The crew taxied into equipment parked beside their path. WheelTug Vision's wingtip and surroundings cameras show obstacles near the engines and wings, so the crew would likely have seen the equipment and stopped.

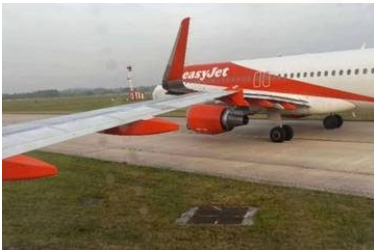
Photo: @Independent on X — [source](#)

**Our assessment (not an investigator finding):** The aircraft was moving under its own (engine) power and the crew misjudged clearance or position. The WheelTug drive alone would not prevent a misjudgement; the relevant element is WheelTug Vision, whose wingtip, nose-gear and surroundings cameras address the fact that pilots cannot see behind or under the aircraft, and even wingtips are not in the normal field of view. Slow, precise electric taxi with engines off also removes jet-blast and engine-ingestion exposure for people nearby.

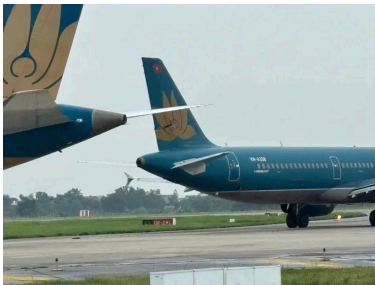
Photo, via @Hanoitimes2 on X — [source](#)

**Our assessment (not an investigator finding):** The aircraft was moving under its own (engine) power and the crew misjudged clearance or position. The WheelTug drive alone would not prevent a misjudgement; the relevant element is WheelTug Vision, whose wingtip, nose-gear and surroundings cameras address the fact that pilots cannot see behind or under the aircraft, and even wingtips are not in the normal field of view. Slow, precise electric taxi with engines off also removes jet-blast and engine-ingestion exposure for people nearby.

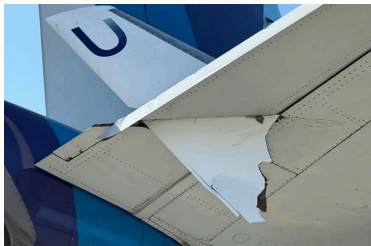
Photo: Southern Transport Prosecutor's Office, via Aviation Safety Network — [source](#)

**Our assessment (not an investigator finding):** The UTair 737 was taxiing under engine power past a 737 that had stopped short of its stand, and its left wingtip struck the other aircraft's tail. The crew cannot see the wingtips from the flight deck. WheelTug Vision's wingtip and surroundings cameras would have shown the UTair crew the clearance to the Nordstar tail in time to stop.

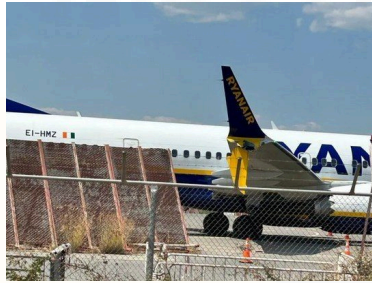
Photo: via Göklerdeyiz.net (goklerdeyiz.net)  
(match confidence: medium) — [source](#)

**Our assessment (not an investigator finding):** The aircraft was moving under its own (engine) power and the crew misjudged clearance or position. The WheelTug drive alone would not prevent a misjudgement; the relevant element is WheelTug Vision, whose wingtip, nose-gear and surroundings cameras address the fact that pilots cannot see behind or under the aircraft, and even wingtips are not in the normal field of view. Slow, precise electric taxi with engines off also removes jet-blast and engine-ingestion exposure for people nearby.

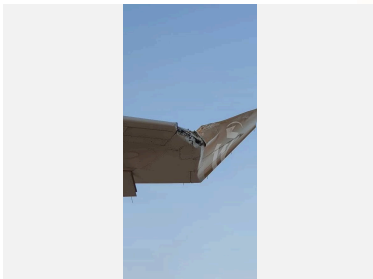
Photo: ASN contributor ("In Sebha airport"),  
via Aviation Safety Network (match  
confidence: medium) — [source](#)

**Our assessment (not an investigator finding):** The aircraft was moving under its own (engine) power and the crew misjudged clearance or position. The WheelTug drive alone would not prevent a misjudgement; the relevant element is WheelTug Vision, whose wingtip, nose-gear and surroundings cameras address the fact that pilots cannot see behind or under the aircraft, and even wingtips are not in the normal field of view. Slow, precise electric taxi with engines off also removes jet-blast and engine-ingestion exposure for people nearby.

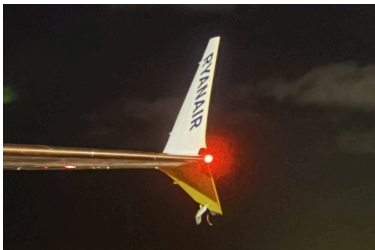
Photo: via Delfi (delfi.ee) — [source](#)

**Our assessment (not an investigator finding):** The aircraft was moving under its own (engine) power and the crew misjudged clearance or position. The WheelTug drive alone would not prevent a misjudgement; the relevant element is WheelTug Vision, whose wingtip, nose-gear and surroundings cameras address the fact that pilots cannot see behind or under the aircraft, and even wingtips are not in the normal field of view. Slow, precise electric taxi with engines off also removes jet-blast and engine-ingestion exposure for people nearby.

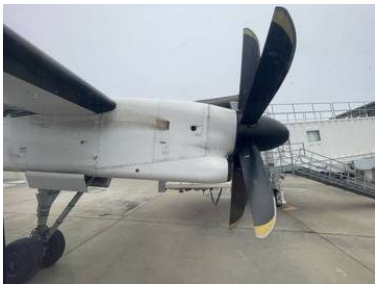
Photo: @SYOTYOU3 on X — [source](#)

**Our assessment (not an investigator finding):** The aircraft was moving under its own (engine) power and the crew misjudged clearance or position. The WheelTug drive alone would not prevent a misjudgement; the relevant element is WheelTug Vision, whose wingtip, nose-gear and surroundings cameras address the fact that pilots cannot see behind or under the aircraft, and even wingtips are not in the normal field of view. Slow, precise electric taxi with engines off also removes jet-blast and engine-ingestion exposure for people nearby.

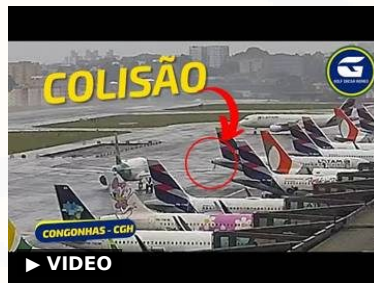
**Our assessment (not an investigator finding):** The aircraft was moving under its own (engine) power and the crew misjudged clearance or position. The WheelTug drive alone would not prevent a misjudgement; the relevant element is WheelTug Vision, whose wingtip, nose-gear and surroundings cameras address the fact that pilots cannot see behind or under the aircraft, and even wingtips are not in the normal field of view. Slow, precise electric taxi with engines off also removes jet-blast and engine-ingestion exposure for people nearby.

| <b>What happened</b> | A Gol Boeing 737 MAX 8 (PR-XMU), was being pushed back from gate 12 at São Paulo-Congonhas Airport, SP (CGH), when it was hit by a taxiing LATAM Airbus A319 (PT-TMT, flight LA3935). The the left wing fence of the A319 struck the APU compartment of the Boeing 737, causing minor damage to the A319's wing fence and moderate damage to the APU compartment. |

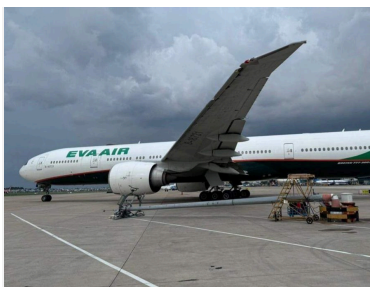
| <b>Damage</b> | Wing damaged |

**Our assessment (not an investigator finding):** The aircraft was moving under its own (engine) power and the crew misjudged clearance or position. The WheelTug drive alone would not prevent a misjudgement; the relevant element is WheelTug Vision, whose wingtip, nose-gear and surroundings cameras address the fact that pilots cannot see behind or under the aircraft, and even wingtips are not in the normal field of view. Slow, precise electric taxi with engines off also removes jet-blast and engine-ingestion exposure for people nearby.

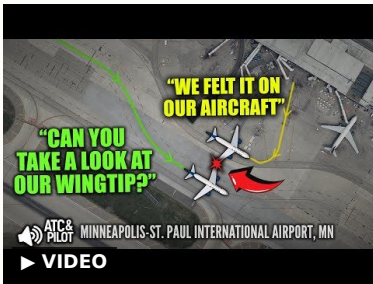
YouTube: Two Delta Planes CLIP WINGTIPS on taxi and push! (Flight Records)  
Still: YouTube thumbnail, Flight Records

**Our assessment (not an investigator finding):** The aircraft was moving under its own (engine) power and the crew misjudged clearance or position. The WheelTug drive alone would not prevent a misjudgement; the relevant element is WheelTug Vision, whose wingtip, nose-gear and surroundings cameras address the fact that pilots cannot see behind or under the aircraft, and even wingtips are not in the normal field of view. Slow, precise electric taxi with engines off also removes jet-blast and engine-ingestion exposure for people nearby.

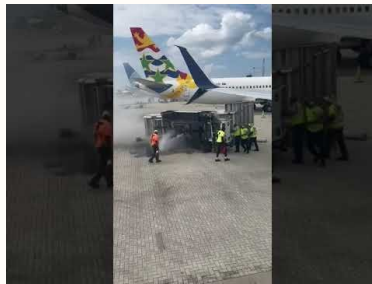
Still: YouTube video "Delta Airplane Damages Wing After Collision With Stairs Truck At Airport On Gra", via Current Events Cayman (auto-frame) — [source](#)

**Our assessment (not an investigator finding):** The aircraft was moving under its own (engine) power and the crew misjudged clearance or position. The WheelTug drive alone would not prevent a misjudgement; the relevant element is WheelTug Vision, whose wingtip, nose-gear and surroundings cameras address the fact that pilots cannot see behind or under the aircraft, and even wingtips are not in the normal field of view. Slow, precise electric taxi with engines off also removes jet-blast and engine-ingestion exposure for people nearby.

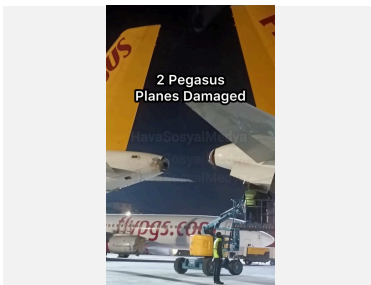
**Our assessment (not an investigator finding):** The aircraft was moving under its own (engine) power and the crew misjudged clearance or position. The WheelTug drive alone would not prevent a misjudgement; the relevant element is WheelTug Vision, whose wingtip, nose-gear and surroundings cameras address the fact that pilots cannot see behind or under the aircraft, and even wingtips are not in the normal field of view. Slow, precise electric taxi with engines off also removes jet-blast and engine-ingestion exposure for people nearby.

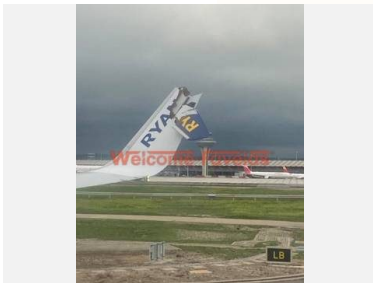
**Our assessment (not an investigator finding):** The aircraft was moving under its own (engine) power and the crew misjudged clearance or position. The WheelTug drive alone would not prevent a misjudgement; the relevant element is WheelTug Vision, whose wingtip, nose-gear and surroundings cameras address the fact that pilots cannot see behind or under the aircraft, and even wingtips are not in the normal field of view. Slow, precise electric taxi with engines off also removes jet-blast and engine-ingestion exposure for people nearby.

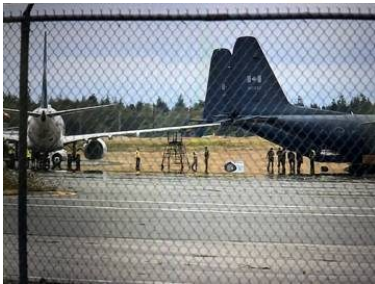
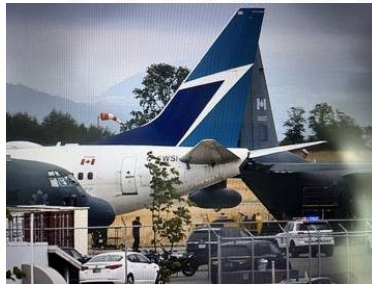
**Our assessment (not an investigator finding):** The aircraft was moving under its own (engine) power and the crew misjudged clearance or position. The WheelTug drive alone would not prevent a misjudgement; the relevant element is WheelTug Vision, whose wingtip, nose-gear and surroundings cameras address the fact that pilots cannot see behind or under the aircraft, and even wingtips are not in the normal field of view. Slow, precise electric taxi with engines off also removes jet-blast and engine-ingestion exposure for people nearby.

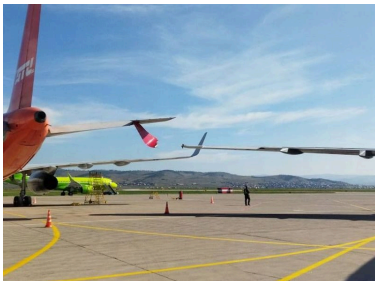
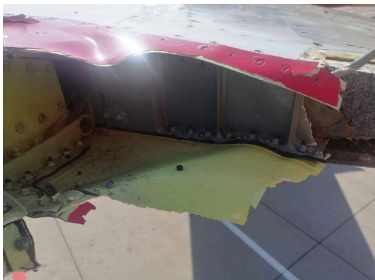
**Our assessment (not an investigator finding):** The aircraft was moving under its own (engine) power and the crew misjudged clearance or position. WheelTug Vision's wingtip, nose-gear and surroundings cameras address the fact that pilots cannot see their wingtips or behind the aircraft; slow, precise electric taxi with engines off also removes jet-blast and ingestion exposure.

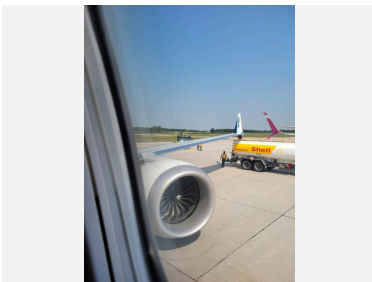
**Our assessment (not an investigator finding):** The aircraft was moving under its own (engine) power and the crew misjudged clearance or position. The WheelTug drive alone would not prevent a misjudgement; the relevant element is WheelTug Vision, whose wingtip, nose-gear and surroundings cameras address the fact that pilots cannot see behind or under the aircraft, and even wingtips are not in the normal field of view. Slow, precise electric taxi with engines off also removes jet-blast and engine-ingestion exposure for people nearby.

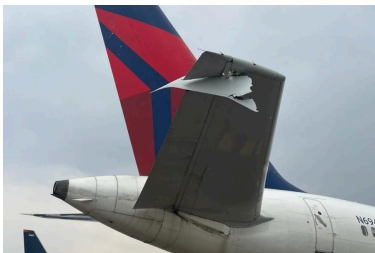
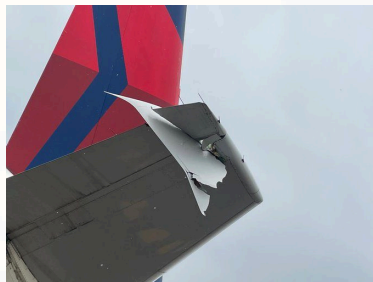
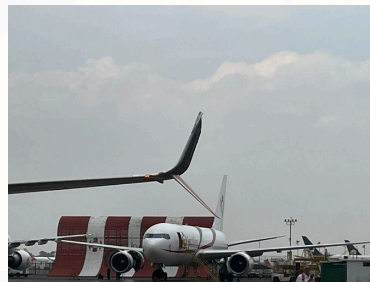
**Our assessment (not an investigator finding):** The aircraft was moving under its own (engine) power and the crew misjudged clearance or position. The WheelTug drive alone would not prevent a misjudgement; the relevant element is WheelTug Vision, whose wingtip, nose-gear and surroundings cameras address the fact that pilots cannot see behind or under the aircraft, and even wingtips are not in the normal field of view. Slow, precise electric taxi with engines off also removes jet-blast and engine-ingestion exposure for people nearby.

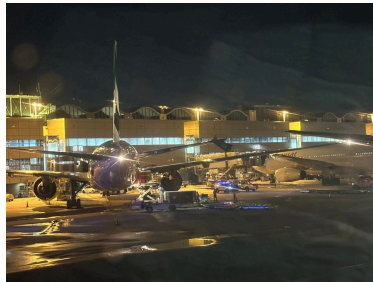
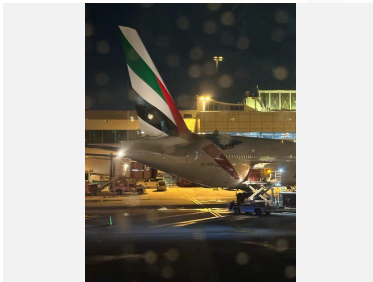
**Our assessment (not an investigator finding):** The aircraft was moving under its own (engine) power and the crew misjudged clearance or position. The WheelTug drive alone would not prevent a misjudgement; the relevant element is WheelTug Vision, whose wingtip, nose-gear and surroundings cameras address the fact that pilots cannot see behind or under the aircraft, and even wingtips are not in the normal field of view. Slow, precise electric taxi with engines off also removes jet-blast and engine-ingestion exposure for people nearby.

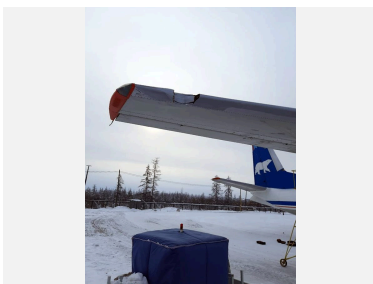
**Our assessment (not an investigator finding):** The aircraft was moving under its own (engine) power and the crew misjudged clearance or position. The WheelTug drive alone would not prevent a misjudgement; the relevant element is WheelTug Vision, whose wingtip, nose-gear and surroundings cameras address the fact that pilots cannot see behind or under the aircraft, and even wingtips are not in the normal field of view. Slow, precise electric taxi with engines off also removes jet-blast and engine-ingestion exposure for people nearby.

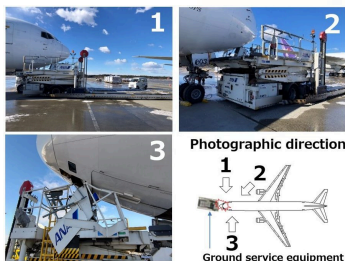
**Our assessment (not an investigator finding):** The aircraft was moving under its own (engine) power and the crew misjudged clearance or position. The WheelTug drive alone would not prevent a misjudgement; the relevant element is WheelTug Vision, whose wingtip, nose-gear and surroundings cameras address the fact that pilots cannot see behind or under the aircraft, and even wingtips are not in the normal field of view. Slow, precise electric taxi with engines off also removes jet-blast and engine-ingestion exposure for people nearby.

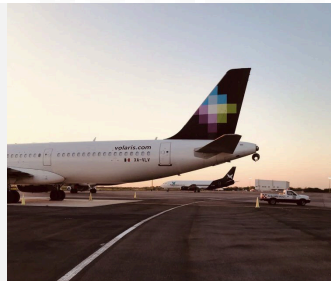
| <b>What happened</b> | An Aeromexico Boeing 737 MAX 8 (XA-MAG) contacted a Volaris Airbus A321 (XA-VLV) at Monterrey International Airport, Mexico. The Boeing 737 was taxiing when the sharklet struck and damaged the APU exhaust of of the A321. |

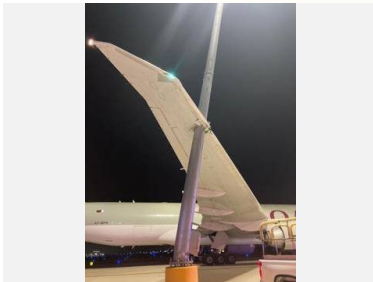
| <b>What happened</b> | <p>A Qatar Airways Cargo Boeing 777 struck a lighting pole during taxi at Chicago- O'Hare International Airport, IL (ORD). The right-hand wing leading edge suffered a serious dent. The flight crew had been instructed to taxi to the northeast cargo ramp via taxiway K, BB and Z and to hold short of runway 09R. The controller then instructed the flight to go via taxiway BB2. However, about 28 m to the right of the centreline of this taxiway there was a lighting pole. The B777 wing span was 64,80 (32,40 m from centre to wing tip). Probable Cause: The ground controller's inappropriate routing of the B777 through a non-movement area, resulting in the airplane's right wingtip contacting a light pole. Contributing to the accident was the lack of an appropriate display of taxiway BB2 as a restricted movement area on the ASDE-X and the flight crew's acceptance of ATC instruction that was contrary to NOTAM information."</p> |

**Our assessment (not an investigator finding):** The aircraft was moving under its own (engine) power and the crew misjudged clearance or position. The WheelTug drive alone would not prevent a misjudgement; the relevant element is WheelTug Vision, whose wingtip, nose-gear and surroundings cameras address the fact that pilots cannot see behind or under the aircraft, and even wingtips are not in the normal field of view. Slow, precise electric taxi with engines off also removes jet-blast and engine-ingestion exposure for people nearby.

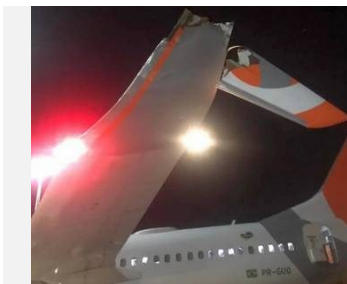
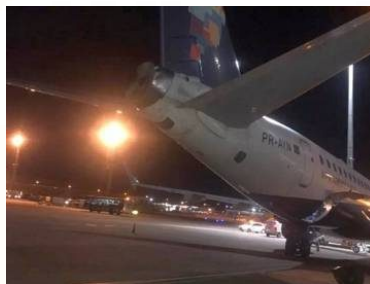
| <b>What happened</b> | While taxiing at night (21:21 local), the left winglet of Gol's 737-8 PR-GUQ struck the APU/horizontal-stabilizer area of Azul ERJ-195 PR-AYN, which was parked. CENIPA found the crew followed the wrong route at the TWY G/K1 hotspot. |
| <b>Damage</b> | Damage to both aircraft (CENIPA) |

**Our assessment (not an investigator finding):** WheelTug Vision cameras showing wingtip clearance would have helped the crew judge the winglet's path past the parked aircraft. The route error itself is a navigation issue.

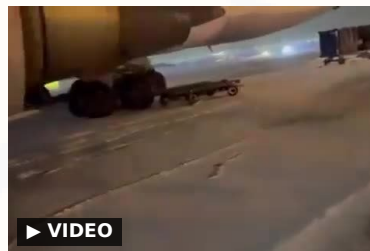
| <b>What happened</b> | China Airlines Cargo flight CI5240 (call sign "Dynasty 5240"), a Boeing 747-400F, struck a baggage cart while taxiing on taxiway S2 entering the southeast cargo ramp area at Chicago's O'Hare Airport. The no.2 engine nacelle was damaged. At this time, it is unknown if further damage was incurred due to the impact. No injuries reported. |

Video: baggage equipment and engine damage  
Video: [https://wheeltug-collisions.netlify.app/videos/GC-0260\\_2.mp4](https://wheeltug-collisions.netlify.app/videos/GC-0260_2.mp4)  
Original: <https://x.com/i/status/1487517491576602626>  
Video and still: Supplied by WheelTug; original: X post.

**Our assessment (not an investigator finding):** The aircraft was moving under its own (engine) power and the crew misjudged clearance or position. The WheelTug drive alone would not prevent a misjudgement; the relevant element is WheelTug Vision, whose wingtip, nose-gear and surroundings cameras address the fact that pilots cannot see behind or under the aircraft, and even wingtips are not in the normal field of view. Slow, precise electric taxi with engines off also removes jet-blast and engine-ingestion exposure for people nearby.

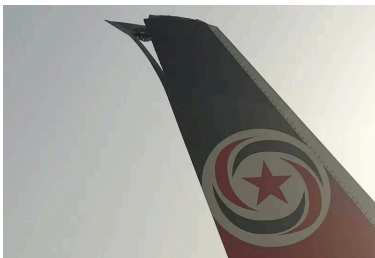
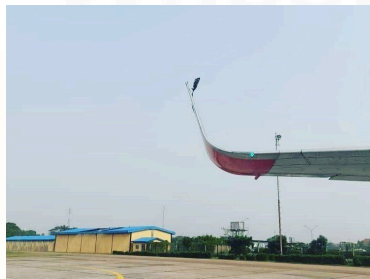
**Our assessment (not an investigator finding):** The aircraft was moving under its own (engine) power and the crew misjudged clearance or position. The WheelTug drive alone would not prevent a misjudgement; the relevant element is WheelTug Vision, whose wingtip, nose-gear and surroundings cameras address the fact that pilots cannot see behind or under the aircraft, and even wingtips are not in the normal field of view. Slow, precise electric taxi with engines off also removes jet-blast and engine-ingestion exposure for people nearby.

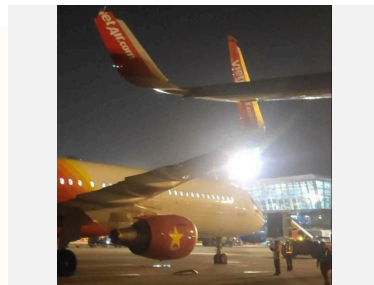
**Our assessment (not an investigator finding):** The aircraft was moving under its own (engine) power and the crew misjudged clearance or position. The WheelTug drive alone would not prevent a misjudgement; the relevant element is WheelTug Vision, whose wingtip, nose-gear and surroundings cameras address the fact that pilots cannot see behind or under the aircraft, and even wingtips are not in the normal field of view. Slow, precise electric taxi with engines off also removes jet-blast and engine-ingestion exposure for people nearby.

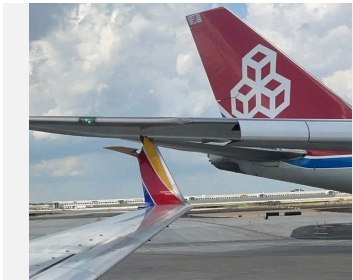
**Our assessment (not an investigator finding):** The aircraft was moving under its own (engine) power and the crew misjudged clearance or position. The WheelTug drive alone would not prevent a misjudgement; the relevant element is WheelTug Vision, whose wingtip, nose-gear and surroundings cameras address the fact that pilots cannot see behind or under the aircraft, and even wingtips are not in the normal field of view. Slow, precise electric taxi with engines off also removes jet-blast and engine-ingestion exposure for people nearby.

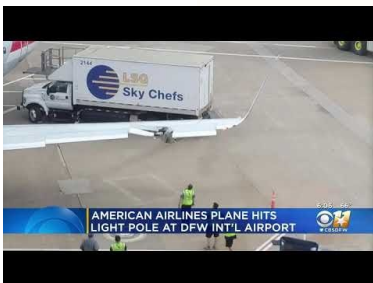
Still: YouTube video "American Airlines Plane Hits Light Pole At DFW Airport", via CBS TEXAS (auto-frame) — [source](#)

**Our assessment (not an investigator finding):** The aircraft was moving under its own (engine) power and the crew misjudged clearance or position. The WheelTug drive alone would not prevent a misjudgement; the relevant element is WheelTug Vision, whose wingtip, nose-gear and surroundings cameras address the fact that pilots cannot see behind or under the aircraft, and even wingtips are not in the normal field of view. Slow, precise electric taxi with engines off also removes jet-blast and engine-ingestion exposure for people nearby.

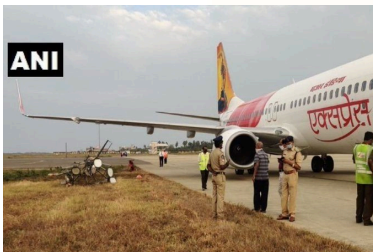
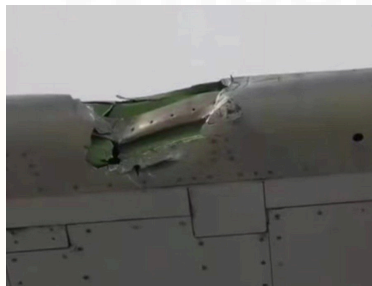
**Our assessment (not an investigator finding):** The aircraft was moving under its own (engine) power and the crew misjudged clearance or position. The WheelTug drive alone would not prevent a misjudgement; the relevant element is WheelTug Vision, whose wingtip, nose-gear and surroundings cameras address the fact that pilots cannot see behind or under the aircraft, and even wingtips are not in the normal field of view. Slow, precise electric taxi with engines off also removes jet-blast and engine-ingestion exposure for people nearby.

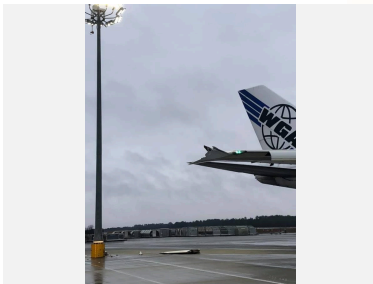
**Our assessment (not an investigator finding):** The aircraft was moving under its own (engine) power and the crew misjudged clearance or position. The WheelTug drive alone would not prevent a misjudgement; the relevant element is WheelTug Vision, whose wingtip, nose-gear and surroundings cameras address the fact that pilots cannot see behind or under the aircraft, and even wingtips are not in the normal field of view. Slow, precise electric taxi with engines off also removes jet-blast and engine-ingestion exposure for people nearby.

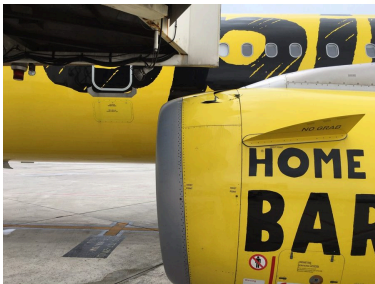
**Our assessment (not an investigator finding):** The aircraft was moving under its own (engine) power and the crew misjudged clearance or position. The WheelTug drive alone would not prevent a misjudgement; the relevant element is WheelTug Vision, whose wingtip, nose-gear and surroundings cameras address the fact that pilots cannot see behind or under the aircraft, and even wingtips are not in the normal field of view. Slow, precise electric taxi with engines off also removes jet-blast and engine-ingestion exposure for people nearby.

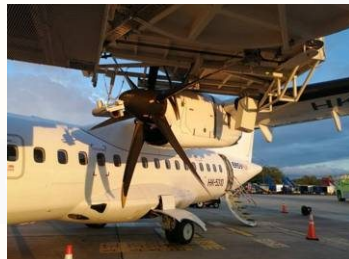
**Our assessment (not an investigator finding):** The aircraft was moving under its own (engine) power and the crew misjudged clearance or position. The WheelTug drive alone would not prevent a misjudgement; the relevant element is WheelTug Vision, whose wingtip, nose-gear and surroundings cameras address the fact that pilots cannot see behind or under the aircraft, and even wingtips are not in the normal field of view. Slow, precise electric taxi with engines off also removes jet-blast and engine-ingestion exposure for people nearby.

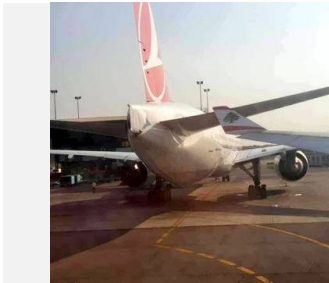
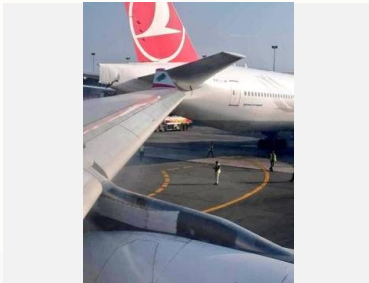
**Our assessment (not an investigator finding):** The aircraft was moving under its own (engine) power and the crew misjudged clearance or position. The WheelTug drive alone would not prevent a misjudgement; the relevant element is WheelTug Vision, whose wingtip, nose-gear and surroundings cameras address the fact that pilots cannot see behind or under the aircraft, and even wingtips are not in the normal field of view. Slow, precise electric taxi with engines off also removes jet-blast and engine-ingestion exposure for people nearby.

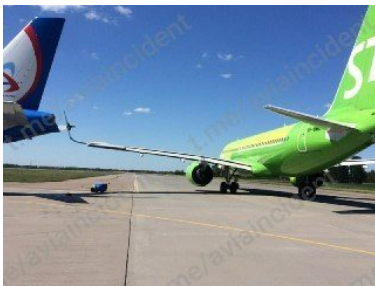
**Our assessment (not an investigator finding):** The aircraft was moving under its own (engine) power and the crew misjudged clearance or position. The WheelTug drive alone would not prevent a misjudgement; the relevant element is WheelTug Vision, whose wingtip, nose-gear and surroundings cameras address the fact that pilots cannot see behind or under the aircraft, and even wingtips are not in the normal field of view. Slow, precise electric taxi with engines off also removes jet-blast and engine-ingestion exposure for people nearby.

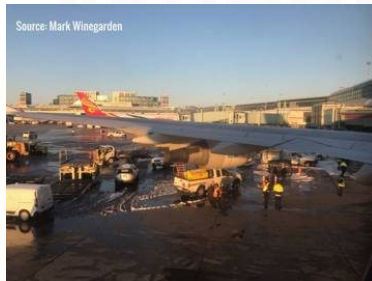
| <b>What happened</b> | A Boeing 747-406M of KLM Royal Dutch Airlines, performing flight KL691, hit a pick-up truck with engine #1 when taxiing to parking position of gate C31 at Toronto-Pearson international Airport (YYZ/CYYZ), Ontario. The return flight was cancelled due to minor damage of the engine. |

**Our assessment (not an investigator finding):** The aircraft was moving under its own (engine) power and the crew misjudged clearance or position. The WheelTug drive alone would not prevent a misjudgement; the relevant element is WheelTug Vision, whose wingtip, nose-gear and surroundings cameras address the fact that pilots cannot see behind or under the aircraft, and even wingtips are not in the normal field of view. Slow, precise electric taxi with engines off also removes jet-blast and engine-ingestion exposure for people nearby.

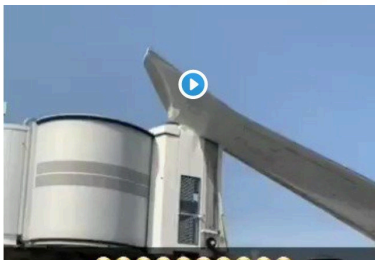
**Our assessment (not an investigator finding):** The aircraft was moving under its own (engine) power and the crew misjudged clearance or position. The WheelTug drive alone would not prevent a misjudgement; the relevant element is WheelTug Vision, whose wingtip, nose-gear and surroundings cameras address the fact that pilots cannot see behind or under the aircraft, and even wingtips are not in the normal field of view. Slow, precise electric taxi with engines off also removes jet-blast and engine-ingestion exposure for people nearby.

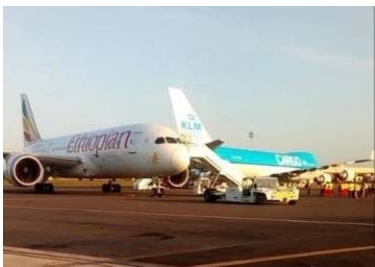
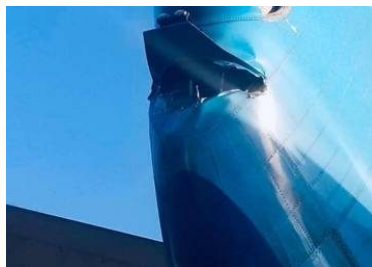
**Our assessment (not an investigator finding):** The aircraft was moving under its own (engine) power and the crew misjudged clearance or position. The WheelTug drive alone would not prevent a misjudgement; the relevant element is WheelTug Vision, whose wingtip, nose-gear and surroundings cameras address the fact that pilots cannot see behind or under the aircraft, and even wingtips are not in the normal field of view. Slow, precise electric taxi with engines off also removes jet-blast and engine-ingestion exposure for people nearby.

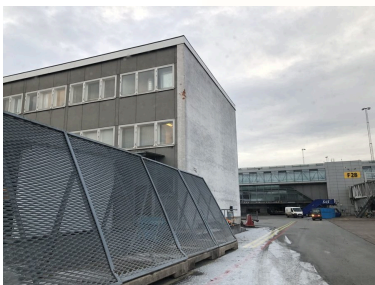
**Our assessment (not an investigator finding):** The aircraft was moving under its own (engine) power and the crew misjudged clearance or position. The WheelTug drive alone would not prevent a misjudgement; the relevant element is WheelTug Vision, whose wingtip, nose-gear and surroundings cameras address the fact that pilots cannot see behind or under the aircraft, and even wingtips are not in the normal field of view. Slow, precise electric taxi with engines off also removes jet-blast and engine-ingestion exposure for people nearby.

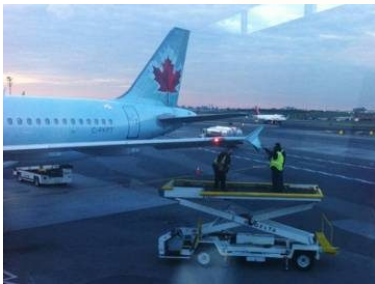
**Our assessment (not an investigator finding):** The aircraft was moving under its own (engine) power and the crew misjudged clearance or position. The WheelTug drive alone would not prevent a misjudgement; the relevant element is WheelTug Vision, whose wingtip, nose-gear and surroundings cameras address the fact that pilots cannot see behind or under the aircraft, and even wingtips are not in the normal field of view. Slow, precise electric taxi with engines off also removes jet-blast and engine-ingestion exposure for people nearby.

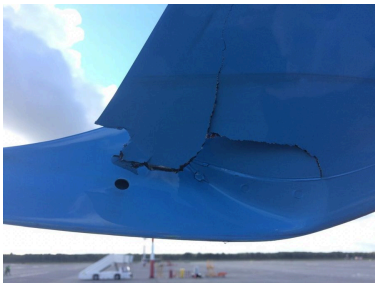
**Our assessment (not an investigator finding):** The aircraft was moving under its own (engine) power and the crew misjudged clearance or position. The WheelTug drive alone would not prevent a misjudgement; the relevant element is WheelTug Vision, whose wingtip, nose-gear and surroundings cameras address the fact that pilots cannot see behind or under the aircraft, and even wingtips are not in the normal field of view. Slow, precise electric taxi with engines off also removes jet-blast and engine-ingestion exposure for people nearby.

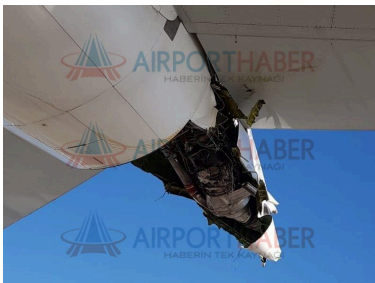
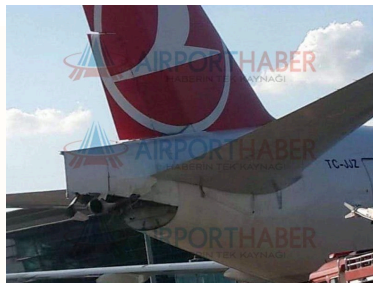
**Our assessment (not an investigator finding):** The aircraft was moving under its own (engine) power and the crew misjudged clearance or position. The WheelTug drive alone would not prevent a misjudgement; the relevant element is WheelTug Vision, whose wingtip, nose-gear and surroundings cameras address the fact that pilots cannot see behind or under the aircraft, and even wingtips are not in the normal field of view. Slow, precise electric taxi with engines off also removes jet-blast and engine-ingestion exposure for people nearby.

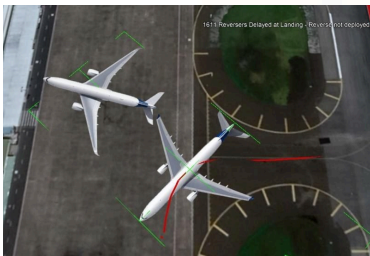
**Our assessment (not an investigator finding):** The aircraft was moving under its own (engine) power and the crew misjudged clearance or position. The WheelTug drive alone would not prevent a misjudgement; the relevant element is WheelTug Vision, whose wingtip, nose-gear and surroundings cameras address the fact that pilots cannot see behind or under the aircraft, and even wingtips are not in the normal field of view. Slow, precise electric taxi with engines off also removes jet-blast and engine-ingestion exposure for people nearby.

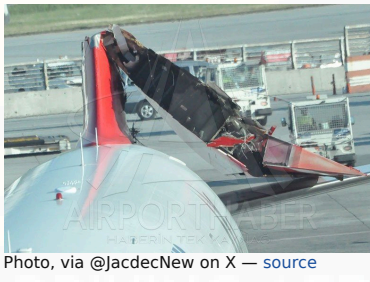
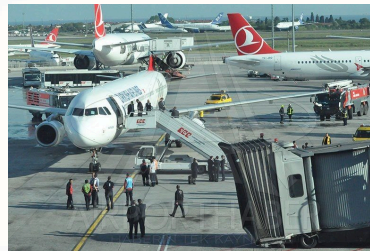
**Our assessment (not an investigator finding):** The aircraft was moving under its own (engine) power and the crew misjudged clearance or position. The WheelTug drive alone would not prevent a misjudgement; the relevant element is WheelTug Vision, whose wingtip, nose-gear and surroundings cameras address the fact that pilots cannot see behind or under the aircraft, and even wingtips are not in the normal field of view. Slow, precise electric taxi with engines off also removes jet-blast and engine-ingestion exposure for people nearby.

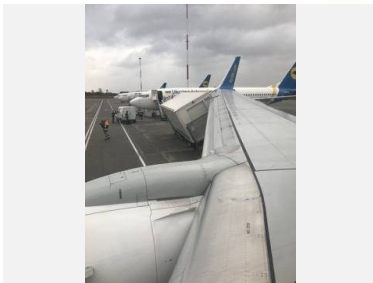
| <b>What happened</b> | Right wing hit a truck when taxiing from stand. Leading edge slat damaged. Passengers taken to destination on UR-PST. |

**Our assessment (not an investigator finding):** The aircraft was moving under its own (engine) power and the crew misjudged clearance or position. The WheelTug drive alone would not prevent a misjudgement; the relevant element is WheelTug Vision, whose wingtip, nose-gear and surroundings cameras address the fact that pilots cannot see behind or under the aircraft, and even wingtips are not in the normal field of view. Slow, precise electric taxi with engines off also removes jet-blast and engine-ingestion exposure for people nearby.

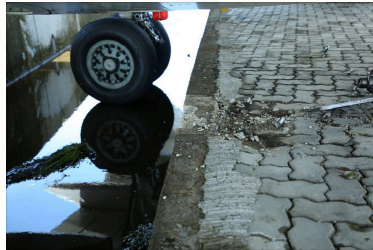
| <b>Damage</b> | Major structural damage, including the nose landing gear, engine inlet and fan cowl, engine struts and lower skin. |

Photo: AAIB India final investigation report, Appendix photo 3 (main gear in the drain) — [source](#)

**Our assessment (not an investigator finding):** WheelTug Vision's near-ground cameras show the nose gear and the pavement edge, which would likely have helped the crew see the drain edge and the taxiway centreline in night rain. WheelTug's low, controlled taxi speed and engines-off operation would also likely have reduced the damage, and would have avoided the three thrust applications made while the aircraft was stuck.

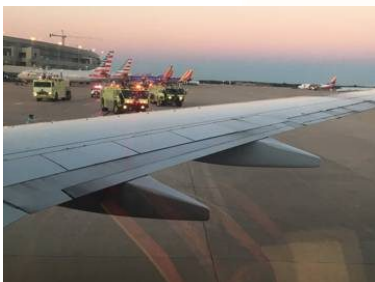
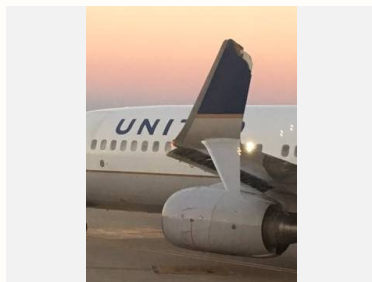
| <b>What happened</b> | A United Airlines Boeing 737-800 (N76504) contacted an American Airlines Boeing 737-800 (N962AN) winglet to winglet at Austin- Bergstrom International Airport. United flight UA898, from Austin to Houston, was taxiing to the runway from gate 19 and American flight AA2675 was taxiing into gate 21 after landing from New York-JFK Airport. The left hand top of the winglet of N76504 broke off. Damage to the American Airlines plane is unclear. |

**Our assessment (not an investigator finding):** The aircraft was moving under its own (engine) power and the crew misjudged clearance or position. The WheelTug drive alone would not prevent a misjudgement; the relevant element is WheelTug Vision, whose wingtip, nose-gear and surroundings cameras address the fact that pilots cannot see behind or under the aircraft, and even wingtips are not in the normal field of view. Slow, precise electric taxi with engines off also removes jet-blast and engine-ingestion exposure for people nearby.

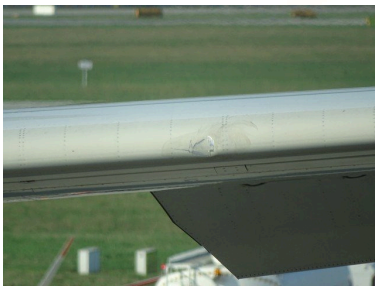
**Our assessment (not an investigator finding):** The aircraft was moving under its own (engine) power and the crew misjudged clearance or position. The WheelTug drive alone would not prevent a misjudgement; the relevant element is WheelTug Vision, whose wingtip, nose-gear and surroundings cameras address the fact that pilots cannot see behind or under the aircraft, and even wingtips are not in the normal field of view. Slow, precise electric taxi with engines off also removes jet-blast and engine-ingestion exposure for people nearby.

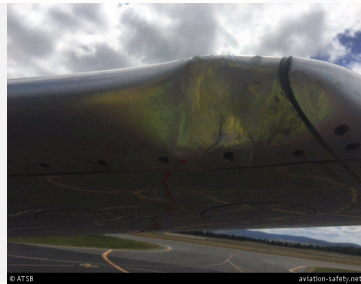
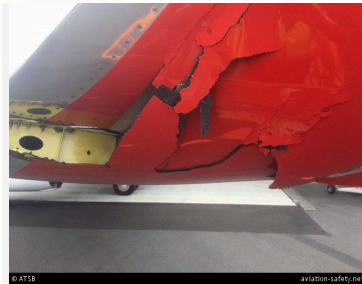
**Our assessment (not an investigator finding):** The aircraft was moving under its own (engine) power and the crew misjudged clearance or position. The WheelTug drive alone would not prevent a misjudgement; the relevant element is WheelTug Vision, whose wingtip, nose-gear and surroundings cameras address the fact that pilots cannot see behind or under the aircraft, and even wingtips are not in the normal field of view. Slow, precise electric taxi with engines off also removes jet-blast and engine-ingestion exposure for people nearby.

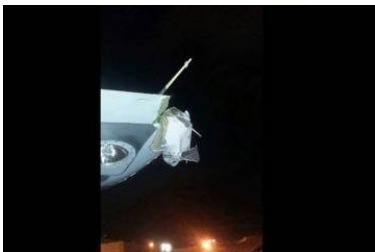
**Our assessment (not an investigator finding):** The aircraft was moving under its own (engine) power and the crew misjudged clearance or position. The WheelTug drive alone would not prevent a misjudgement; the relevant element is WheelTug Vision, whose wingtip, nose-gear and surroundings cameras address the fact that pilots cannot see behind or under the aircraft, and even wingtips are not in the normal field of view. Slow, precise electric taxi with engines off also removes jet-blast and engine-ingestion exposure for people nearby.

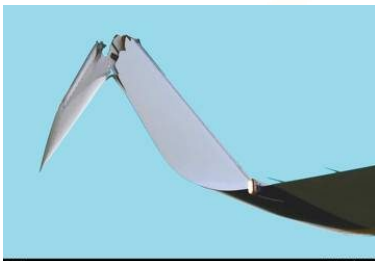
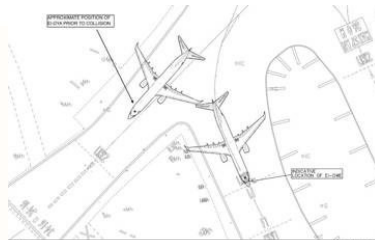
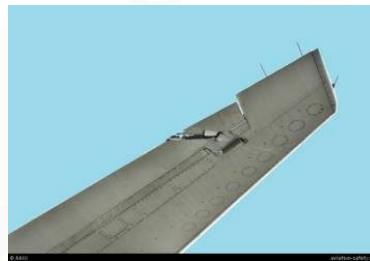
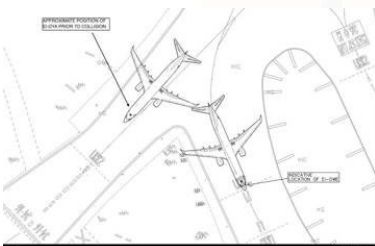
**Our assessment (not an investigator finding):** The aircraft was moving under its own (engine) power and the crew misjudged clearance or position. The WheelTug drive alone would not prevent a misjudgement; the relevant element is WheelTug Vision, whose wingtip, nose-gear and surroundings cameras address the fact that pilots cannot see behind or under the aircraft, and even wingtips are not in the normal field of view. Slow, precise electric taxi with engines off also removes jet-blast and engine-ingestion exposure for people nearby.

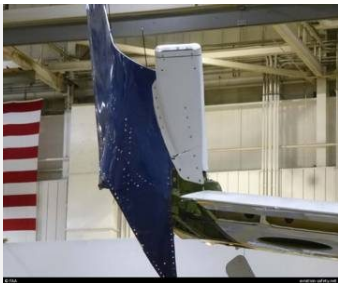
**Our assessment (not an investigator finding):** The aircraft was moving under its own (engine) power and the crew misjudged clearance or position. The WheelTug drive alone would not prevent a misjudgement; the relevant element is WheelTug Vision, whose wingtip, nose-gear and surroundings cameras address the fact that pilots cannot see behind or under the aircraft, and even wingtips are not in the normal field of view. Slow, precise electric taxi with engines off also removes jet-blast and engine-ingestion exposure for people nearby.

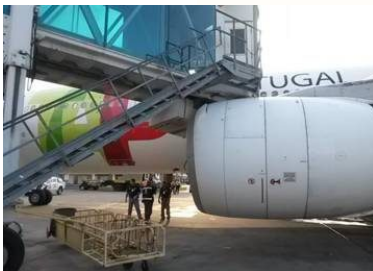
**Our assessment (not an investigator finding):** The aircraft was moving under its own (engine) power and the crew misjudged clearance or position. The WheelTug drive alone would not prevent a misjudgement; the relevant element is WheelTug Vision, whose wingtip, nose-gear and surroundings cameras address the fact that pilots cannot see behind or under the aircraft, and even wingtips are not in the normal field of view. Slow, precise electric taxi with engines off also removes jet-blast and engine-ingestion exposure for people nearby.

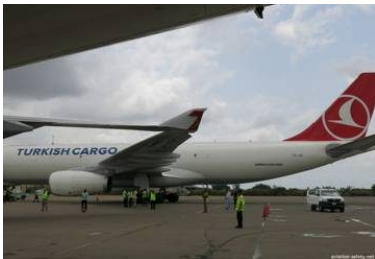
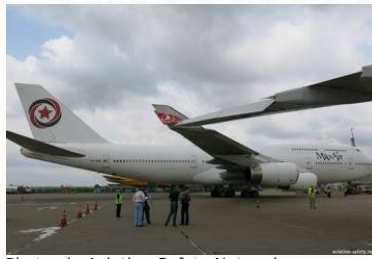
**Our assessment (not an investigator finding):** The aircraft was moving under its own (engine) power and the crew misjudged clearance or position. The WheelTug drive alone would not prevent a misjudgement; the relevant element is WheelTug Vision, whose wingtip, nose-gear and surroundings cameras address the fact that pilots cannot see behind or under the aircraft, and even wingtips are not in the normal field of view. Slow, precise electric taxi with engines off also removes jet-blast and engine-ingestion exposure for people nearby.

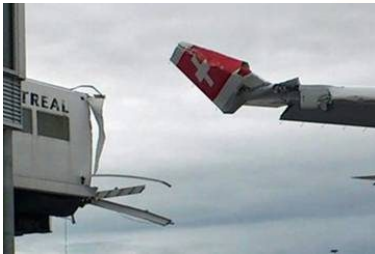
**Our assessment (not an investigator finding):** wingtip-clearance cameras would have shown the vehicle next to the right wing.

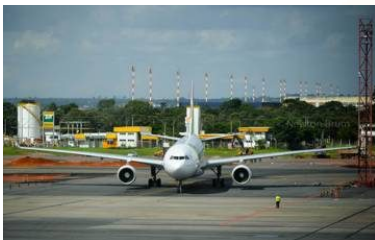
**Our assessment (not an investigator finding):** The aircraft was moving under its own (engine) power and the crew misjudged clearance or position. The WheelTug drive alone would not prevent a misjudgement; the relevant element is WheelTug Vision, whose wingtip, nose-gear and surroundings cameras address the fact that pilots cannot see behind or under the aircraft, and even wingtips are not in the normal field of view. Slow, precise electric taxi with engines off also removes jet-blast and engine-ingestion exposure for people nearby.

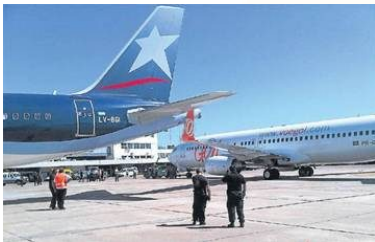
**Our assessment (not an investigator finding):** The aircraft was moving under its own (engine) power and the crew misjudged clearance or position. The WheelTug drive alone would not prevent a misjudgement; the relevant element is WheelTug Vision, whose wingtip, nose-gear and surroundings cameras address the fact that pilots cannot see behind or under the aircraft, and even wingtips are not in the normal field of view. Slow, precise electric taxi with engines off also removes jet-blast and engine-ingestion exposure for people nearby.

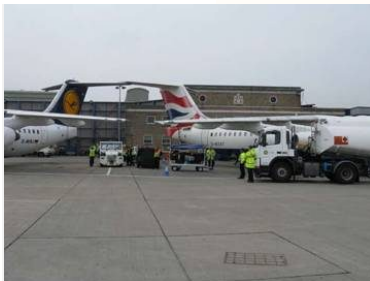
**Our assessment (not an investigator finding):** The aircraft was moving under its own (engine) power and the crew misjudged clearance or position. The WheelTug drive alone would not prevent a misjudgement; the relevant element is WheelTug Vision, whose wingtip, nose-gear and surroundings cameras address the fact that pilots cannot see behind or under the aircraft, and even wingtips are not in the normal field of view. Slow, precise electric taxi with engines off also removes jet-blast and engine-ingestion exposure for people nearby.

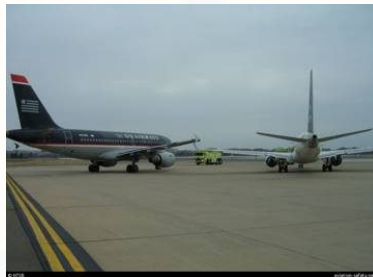
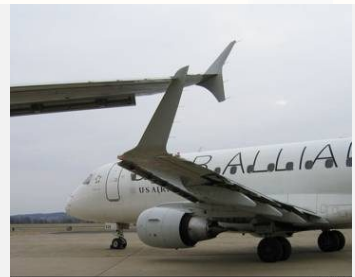
**Our assessment (not an investigator finding):** The aircraft was moving under its own (engine) power and the crew misjudged clearance or position. The WheelTug drive alone would not prevent a misjudgement; the relevant element is WheelTug Vision, whose wingtip, nose-gear and surroundings cameras address the fact that pilots cannot see behind or under the aircraft, and even wingtips are not in the normal field of view. Slow, precise electric taxi with engines off also removes jet-blast and engine-ingestion exposure for people nearby.

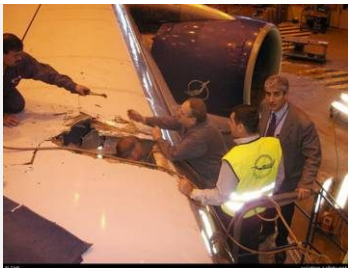
**Our assessment (not an investigator finding):** The aircraft was moving under its own (engine) power and the crew misjudged clearance or position. The WheelTug drive alone would not prevent a misjudgement; the relevant element is WheelTug Vision, whose wingtip, nose-gear and surroundings cameras address the fact that pilots cannot see behind or under the aircraft, and even wingtips are not in the normal field of view. Slow, precise electric taxi with engines off also removes jet-blast and engine-ingestion exposure for people nearby.

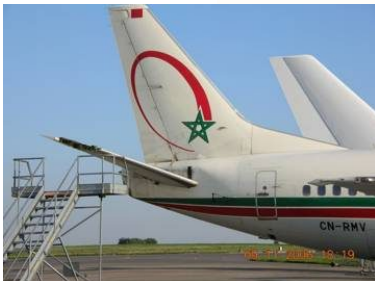
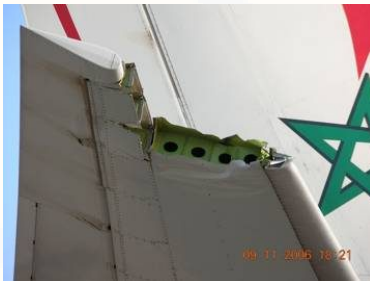
**Our assessment (not an investigator finding):** The aircraft was moving under its own (engine) power and the crew misjudged clearance or position. The WheelTug drive alone would not prevent a misjudgement; the relevant element is WheelTug Vision, whose wingtip, nose-gear and surroundings cameras address the fact that pilots cannot see behind or under the aircraft, and even wingtips are not in the normal field of view. Slow, precise electric taxi with engines off also removes jet-blast and engine-ingestion exposure for people nearby.

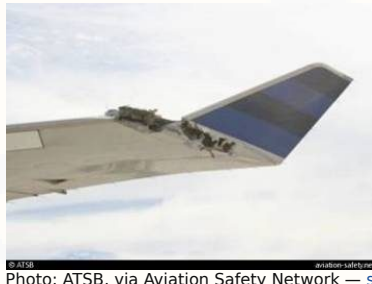
**Our assessment (not an investigator finding):** The aircraft was moving under its own (engine) power and the crew misjudged clearance or position. The WheelTug drive alone would not prevent a misjudgement; the relevant element is WheelTug Vision, whose wingtip, nose-gear and surroundings cameras address the fact that pilots cannot see behind or under the aircraft, and even wingtips are not in the normal field of view. Slow, precise electric taxi with engines off also removes jet-blast and engine-ingestion exposure for people nearby.

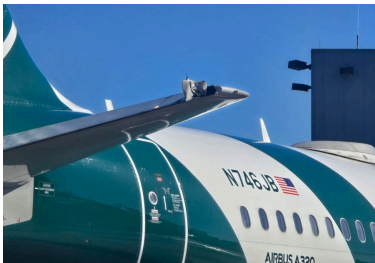
| <b>What happened</b> | JetBlue flight 87, an Airbus A320, hit a light pole on pushback. The right horizontal stabilizer tip was damaged. |

**Our assessment (not an investigator finding):** The tug, its driver or the pushback geometry was in the causal chain. A WheelTug pushback is pilot-controlled with no tug at the nose, which removes the tug and tug-driver element. Clearance judgement moves to the flight deck, where WheelTug Vision cameras showing wingtips, tail-side surroundings and nose gear are intended to compensate for the pilots' lack of a rearward view.

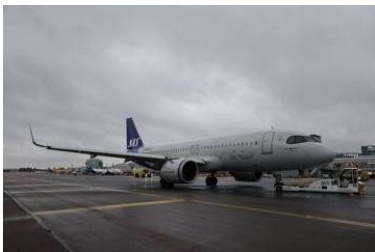
**Our assessment (not an investigator finding):** The tug, its driver or the pushback geometry was in the causal chain. A WheelTug pushback is pilot-controlled with no tug at the nose, which removes the tug and tug-driver element. Clearance judgement moves to the flight deck, where WheelTug Vision cameras showing wingtips, tail-side surroundings and nose gear are intended to compensate for the pilots' lack of a rearward view.

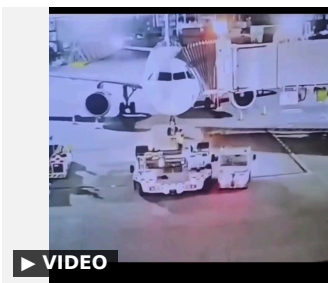
| <b>What happened</b> | CCTV footage shows a pushback tug that fails to stop before the aircraft. It strikes the nose landing gear, and a worker is caught between the tug and the gear. |

**Our assessment (not an investigator finding):** With WheelTug, pushback is made under the aircraft's own power with no tug at the nose gear, so a worker could not be crushed between a tug and the gear.

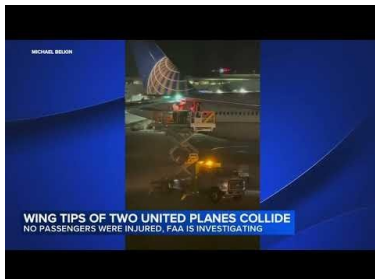
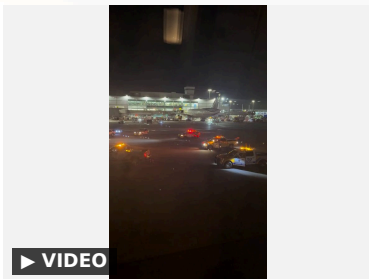
| <b>What happened</b> | United Airlines flight UA1871, a Boeing 737-800 (N26232), and United Airlines flight UA796, a Boeing 737 MAX 9 (N17594), were damaged in a ground contact incident at San Francisco International Airport, CA (SFO). Flight UA1871 was being pushed back from the gate at the time of the incident. The left-hand horizontal stabilizer impacted the APU exhaust of flight UA796 which was still parked at the gate. |

**Our assessment (not an investigator finding):** The tug, its driver or the pushback geometry was in the causal chain. A WheelTug pushback is pilot-controlled with no tug at the nose, which removes the tug and tug-driver element. Clearance judgement moves to the flight deck, where WheelTug Vision cameras showing wingtips, tail-side surroundings and nose gear are intended to compensate for the pilots' lack of a rearward view.

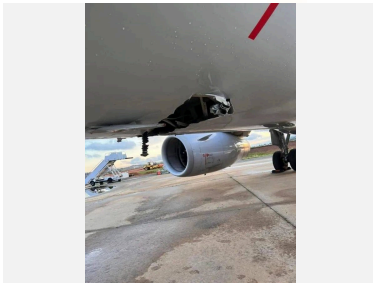
**Our assessment (not an investigator finding):** The tug, its driver or the pushback geometry was in the causal chain. A WheelTug pushback is pilot-controlled with no tug at the nose, which removes the tug and tug-driver element. Clearance judgement moves to the flight deck, where WheelTug Vision cameras showing wingtips, tail-side surroundings and nose gear are intended to compensate for the pilots' lack of a rearward view.

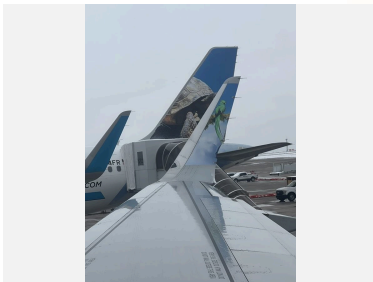
**Our assessment (not an investigator finding):** The tug, its driver or the pushback geometry was in the causal chain. A WheelTug pushback is pilot-controlled with no tug at the nose, which removes the tug and tug-driver element. Clearance judgement moves to the flight deck, where WheelTug Vision cameras showing wingtips, tail-side surroundings and nose gear are intended to compensate for the pilots' lack of a rearward view.
