# Aircraft Ground Collisions, 2004-2026

Pushback, towing, taxi, jet blast and FOD incidents, and how WheelTug and WheelTug Vision could have helped

October 2026

637 incidents · 2004 – Oct 29, 2026

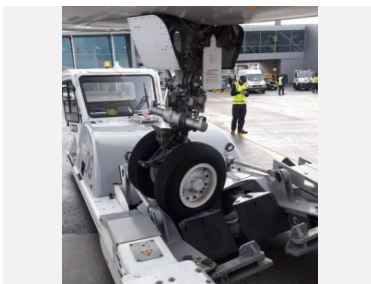
**Our assessment (not an investigator finding):** The photo shows a tug-loading error at the nose gear. With WheelTug, pushback is done by the flight crew under the aircraft's own power, with no tug attached to the nose gear, so this kind of error could not occur on a WheelTug pushback.

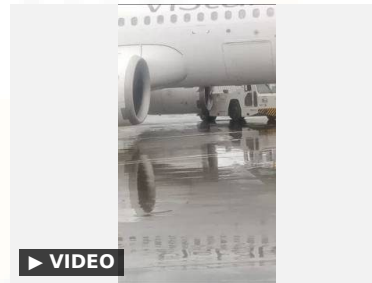
**Our assessment (not an investigator finding):** The tug, its driver or the pushback geometry was in the causal chain. A WheelTug pushback is pilot-controlled with no tug at the nose, which removes the tug and tug-driver element. Clearance judgement moves to the flight deck, where WheelTug Vision cameras showing wingtips, tail-side surroundings and nose gear are intended to compensate for the pilots' lack of a rearward view.

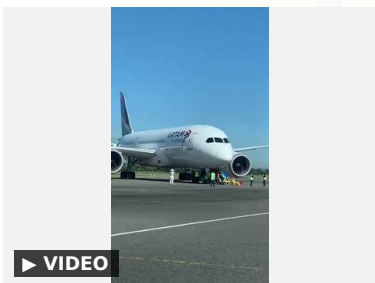
**Our assessment (not an investigator finding):** The tug, its driver or the pushback geometry was in the causal chain. A WheelTug pushback is pilot-controlled with no tug at the nose, which removes the tug and tug-driver element. Clearance judgement moves to the flight deck, where WheelTug Vision cameras showing wingtips, tail-side surroundings and nose gear are intended to compensate for the pilots' lack of a rearward view.

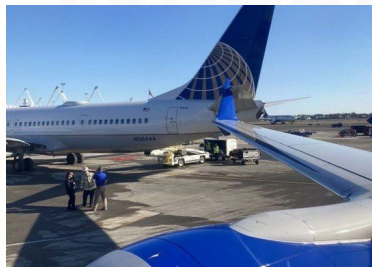
**Our assessment (not an investigator finding):** The tug, its driver or the pushback geometry was in the causal chain. A WheelTug pushback is pilot-controlled with no tug at the nose, which removes the tug and tug-driver element. Clearance judgement moves to the flight deck, where WheelTug Vision cameras showing wingtips, tail-side surroundings and nose gear are intended to compensate for the pilots' lack of a rearward view.

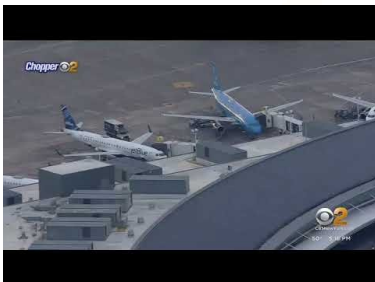
Still: YouTube video "FAA: JetBlue plane hits tail of parked plane while leaving gate", via CBS New York (auto-frame) — [source](#)

**Our assessment (not an investigator finding):** The tug, its driver or the pushback geometry was in the causal chain. A WheelTug pushback is pilot-controlled with no tug at the nose, which removes the tug and tug-driver element. Clearance judgement moves to the flight deck, where WheelTug Vision cameras showing wingtips, tail-side surroundings and nose gear are intended to compensate for the pilots' lack of a rearward view.

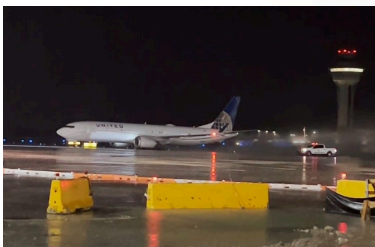
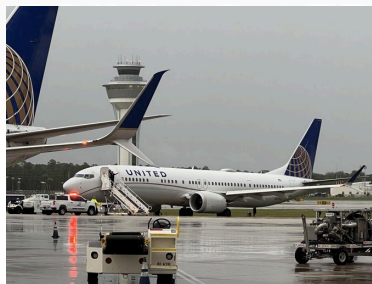
**Our assessment (not an investigator finding):** The tug, its driver or the pushback geometry was in the causal chain. A WheelTug pushback is pilot-controlled with no tug at the nose, which removes the tug and tug-driver element. Clearance judgement moves to the flight deck, where WheelTug Vision cameras showing wingtips, tail-side surroundings and nose gear are intended to compensate for the pilots' lack of a rearward view.

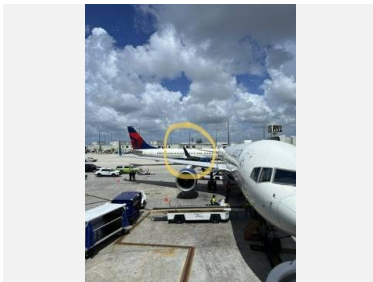
| <b>Damage</b> | Not stated |

**Our assessment (not an investigator finding):** The tug, its driver or the pushback geometry was in the causal chain. A WheelTug pushback is pilot-controlled with no tug at the nose, which removes the tug and tug-driver element. Clearance judgement moves to the flight deck, where WheelTug Vision cameras showing wingtips, tail-side surroundings and nose gear are intended to compensate for the pilots' lack of a rearward view.

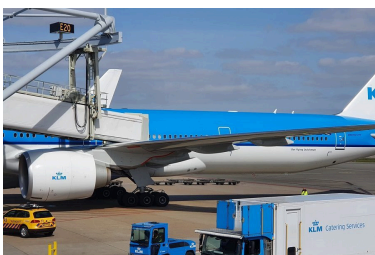
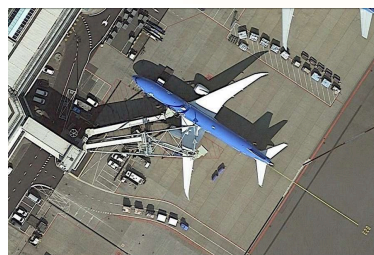
| <b>What happened</b> | The aircraft was pushed back while the over-wing boarding bridge was still too low or attached, and it struck the wing after about 8-10 m. KLM reported minor wing damage. It was a cargo-in-cabin flight with no passengers. |
| <b>Damage</b> | Minor wing damage. |
| <b>Note</b> | KLM said the bridge was too low because of a malfunction; the photos show it still attached. Some posts give 24 Apr 2021 (the publication date). |

**Our assessment (not an investigator finding):** With WheelTug the flight crew backs the aircraft out under its own power ('wheelback') with no tug or tow bar, and WheelTug Vision shows the wingtips and surroundings; the pushback-team misjudgement behind this contact would not arise in the same way.

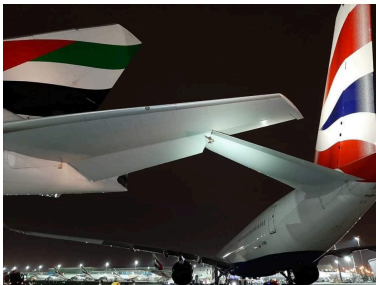
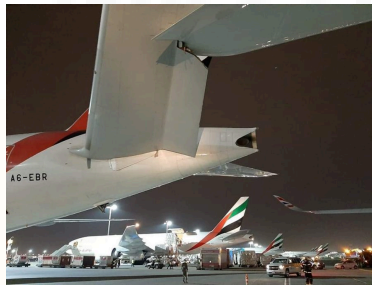
| <b>Damage</b> | Not stated |

**Our assessment (not an investigator finding):** The tug, its driver or the pushback geometry was in the causal chain. A WheelTug pushback is pilot-controlled with no tug at the nose, which removes the tug and tug-driver element. Clearance judgement moves to the flight deck, where WheelTug Vision cameras showing wingtips, tail-side surroundings and nose gear are intended to compensate for the pilots' lack of a rearward view.

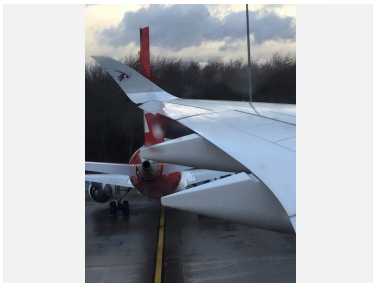
Photo: ASN contributor ("From the Qatar flight involved in the incident."), via Aviation Safety Network (match confidence: medium)  
— [source](#)

**Our assessment (not an investigator finding):** The tug, its driver or the pushback geometry was in the causal chain. A WheelTug pushback is pilot-controlled with no tug at the nose, which removes the tug and tug-driver element. Clearance judgement moves to the flight deck, where WheelTug Vision cameras showing wingtips, tail-side surroundings and nose gear are intended to compensate for the pilots' lack of a rearward view.

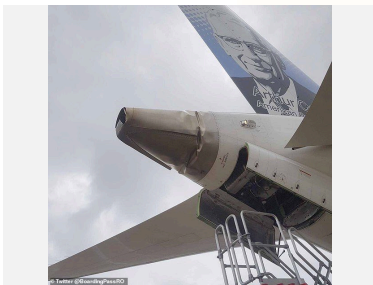
| <b>Damage</b> | Minor, repaired |
| <b>Official investigation</b> | Investigating agency: AAIB Report number: EW/G2019/08/12 Status: Investigation completed Duration: 7 months Final report |

**Our assessment (not an investigator finding):** The tug, its driver or the pushback geometry was in the causal chain. A WheelTug pushback is pilot-controlled with no tug at the nose, which removes the tug and tug-driver element. Clearance judgement moves to the flight deck, where WheelTug Vision cameras showing wingtips, tail-side surroundings and nose gear are intended to compensate for the pilots' lack of a rearward view.

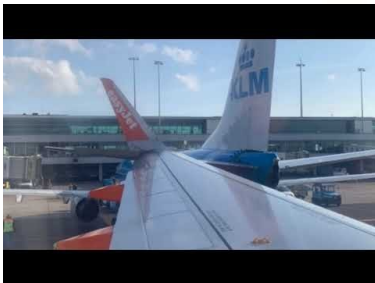
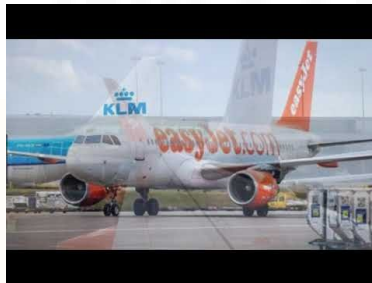
Still: YouTube video "KLM Easyjet hit each other on Schiphol airport 9-7-2019", via Typeratingtraining Boeing Airbus (auto-frame) — [source](#)

Still: YouTube video "KLM hits Easyjet Schiphol airport", via Typeratingtraining Boeing Airbus (auto-frame) (match confidence: medium) — [source](#)

**Our assessment (not an investigator finding):** The tug, its driver or the pushback geometry was in the causal chain. A WheelTug pushback is pilot-controlled with no tug at the nose, which removes the tug and tug-driver element. Clearance judgement moves to the flight deck, where WheelTug Vision cameras showing wingtips, tail-side surroundings and nose gear are intended to compensate for the pilots' lack of a rearward view.

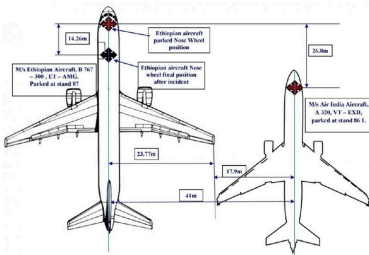
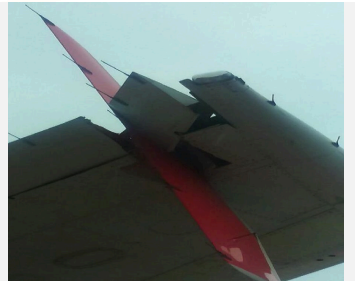
| <b>Official investigation</b> | Investigated by the AAIB India (summarised by SKYbrary). |

**Our assessment (not an investigator finding):** With WheelTug the flight crew backs the aircraft out under its own power ('wheelback') with no tug or tow bar, and WheelTug Vision shows the wingtips and surroundings; the pushback-team misjudgement behind this contact would not arise in the same way.

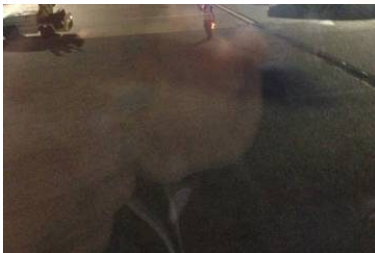
Passenger photo posted to Aviation Safety Network — [source](#)

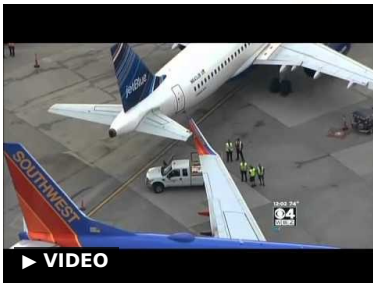
| <b>Damage</b> | Winglet and horizontal stabilizer damaged |

► VIDEO  
YouTube: Southwest, JetBlue Planes Collide At Logan Airport Gate (CBS Boston)  
Still: YouTube thumbnail, CBS Boston

**Our assessment (not an investigator finding):** The tug, its driver or the pushback geometry was in the causal chain. A WheelTug pushback is pilot-controlled with no tug at the nose, which removes the tug and tug-driver element. Clearance judgement moves to the flight deck, where WheelTug Vision cameras showing wingtips, tail-side surroundings and nose gear are intended to compensate for the pilots' lack of a rearward view.

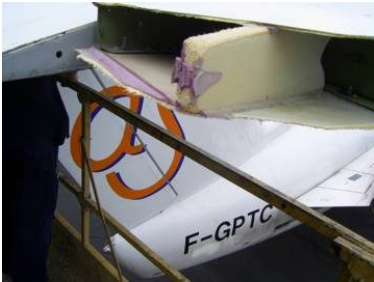
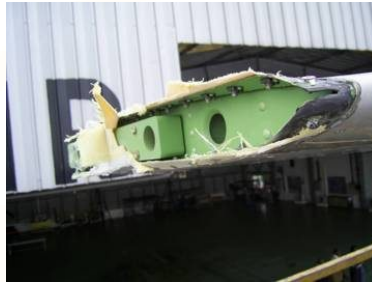
| <b>What happened</b> | While the aircraft was being pushed back from the hangar, the driver of the pushback tug mistakenly turned left before the correct time. Subsequently the Left edge of the Horizontal was damaged. Nobody was injured. |

Photo via Aviation Safety Network (photographer not stated) — [source](#)

**Our assessment (not an investigator finding):** The tug, its driver or the pushback geometry was in the causal chain. A WheelTug pushback is pilot-controlled with no tug at the nose, which removes the tug and tug-driver element. Clearance judgement moves to the flight deck, where WheelTug Vision cameras showing wingtips, tail-side surroundings and nose gear are intended to compensate for the pilots' lack of a rearward view.

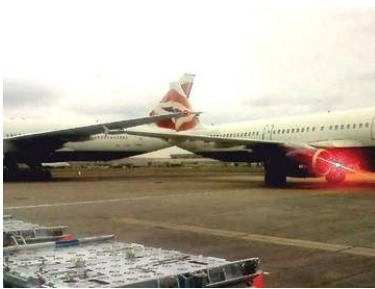
Photo: UK AAIB report — [source](#)

**Our assessment (not an investigator finding):** The tug, its driver or the pushback geometry was in the causal chain. A WheelTug pushback is pilot-controlled with no tug at the nose, which removes the tug and tug-driver element. Clearance judgement moves to the flight deck, where WheelTug Vision cameras showing wingtips, tail-side surroundings and nose gear are intended to compensate for the pilots' lack of a rearward view.

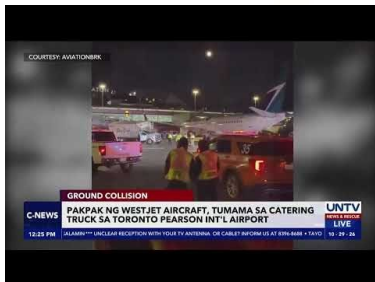
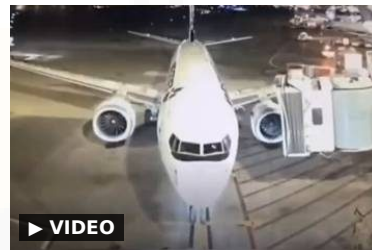
| <b>What happened</b> | WestJet Flight WS2221, Boeing 737 MAX 8, collided with a food catering truck as it taxied into the gate at Toronto (YYZ). The truck was substantially damaged. |
| <b>Note</b> | Correction (TSB/WestJet): the aircraft was being towed with no crew or passengers to an overnight pad; categorised as towing. |

Still: YouTube video "Pakpak ng Westjet Aircraft, tumama sa catering truck sa Toronto Pearson Int'l Ai", via UNTV News and Rescue (auto-frame) (match confidence: medium) — [source](#)

Video posted on X by @Breaking911 (2026-10-29)  
Still: X video preview frame, @Breaking911 on X

**Our assessment (not an investigator finding):** The aircraft was under tow (repositioning, maintenance or gate move) and the towing team misjudged clearance. Where such moves could be done under WheelTug power with a crew on board, the tug and tow bar would be removed and WheelTug Vision would give the operator a camera view of wingtips and tail. Unmanned maintenance tows would likely still use tugs, so relevance is partial.

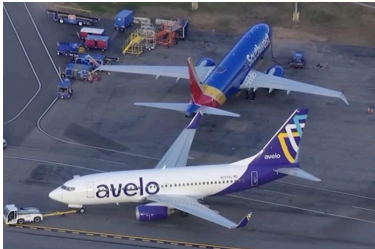
| <b>Damage</b> | Minor |

Photo, via @Fahadnaimb on X — [source](#)

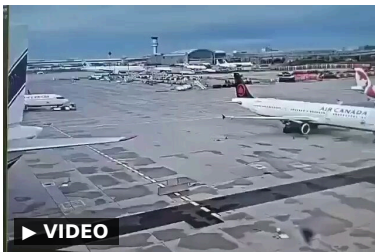
| <b>Damage</b> | Winglet and stabilizer damage |

Video posted on X by @Mrgunsngear (2025-10-15)

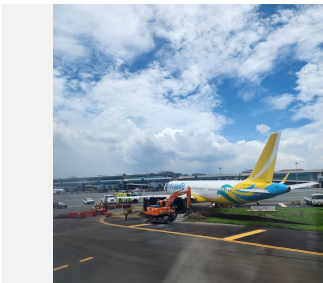
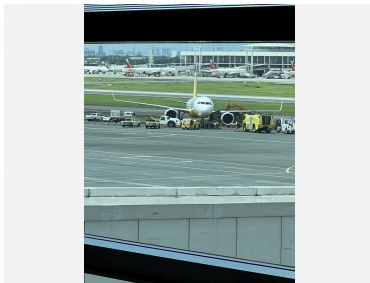
| <b>Damage</b> | Not stated in the source. |

Photo: @JacdecNew on X — [source](#)

**Our assessment (not an investigator finding):** The aircraft was under tow (repositioning, maintenance or gate move) and the towing team misjudged clearance. Where such moves could be done under WheelTug power with a crew on board, the tug and tow bar would be removed and WheelTug Vision would give the operator a camera view of wingtips and tail. Unmanned maintenance tows would likely still use tugs, so relevance is partial.

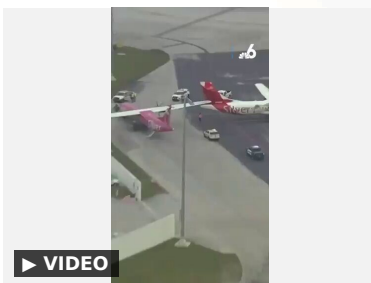
| <b>Damage</b> | Minor damage |

Video posted on X by @jacdecNew (2024-01-05)  
Still: X video preview frame, @jacdecNew on X

**Our assessment (not an investigator finding):** The aircraft was under tow (repositioning, maintenance or gate move) and the towing team misjudged clearance. Where such moves could be done under WheelTug power with a crew on board, the tug and tow bar would be removed and WheelTug Vision would give the operator a camera view of wingtips and tail. Unmanned maintenance tows would likely still use tugs, so relevance is partial.

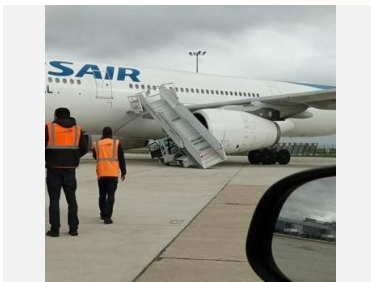
| <b>What happened</b> | A Corsair Airbus A330-343E, intended to perform flight CRL894 to Felix Houphouet Boigny Airport (ABJ/DIAP), Abidjan, Ivory Coast, hit a mobile aircraft stairs with the left engine nacelle when being towed at Paris-Orly Airport (ORY/LFPO). The empty aircraft received minor damage and the flight was cancelled. Ex VQ-BEL, F-WWYR (reserved as EC-ODR for Wamos Air) |

Photo: @airplusnews on X — [source](#)

**Our assessment (not an investigator finding):** The aircraft was under tow (repositioning, maintenance or gate move) and the towing team misjudged clearance. Where such moves could be done under WheelTug power with a crew on board, the tug and tow bar would be removed and WheelTug Vision would give the operator a camera view of wingtips and tail. Unmanned maintenance tows would likely still use tugs, so relevance is partial.

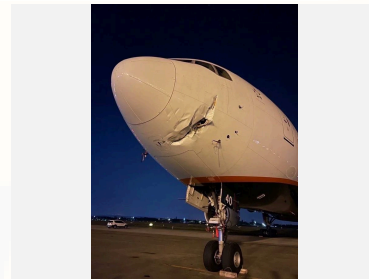
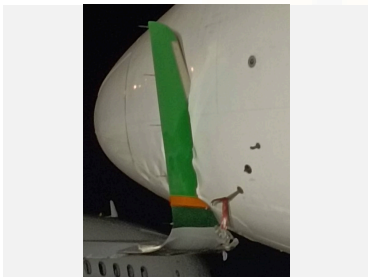
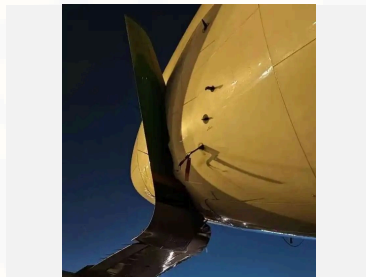
## GC-0317 · 2023-04-16 · Taiwan Taoyuan International Airport (TPE/RCTP) - Taiwan

Photo: Supplied by WheelTug

**Our assessment (not an investigator finding):** The aircraft was under tow (repositioning, maintenance or gate move) and the towing team misjudged clearance. Where such moves could be done under WheelTug power with a crew on board, the tug and tow bar would be removed and WheelTug Vision would give the operator a camera view of wingtips and tail. Unmanned maintenance tows would likely still use tugs, so relevance is partial.

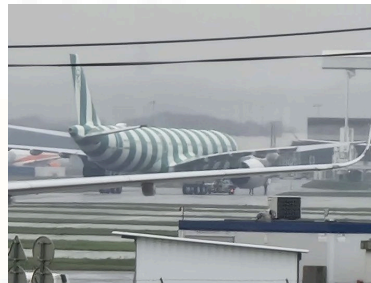
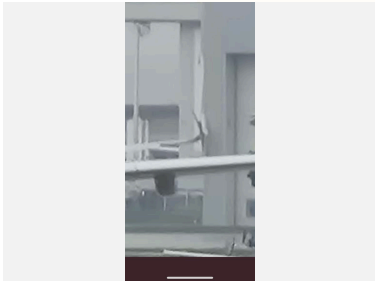
Photo: Supplied by WheelTug; original: JACDEC on X — [source](#)

**Our assessment (not an investigator finding):** The aircraft was under tow (repositioning, maintenance or gate move) and the towing team misjudged clearance. Where such moves could be done under WheelTug power with a crew on board, the tug and tow bar would be removed and WheelTug Vision would give the operator a camera view of wingtips and tail. Unmanned maintenance tows would likely still use tugs, so relevance is partial.

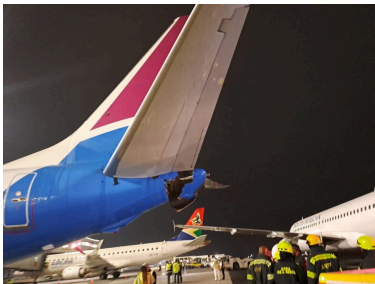
Photo, via @JacdecNew on X — [source](#)

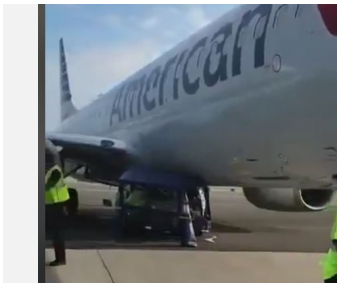
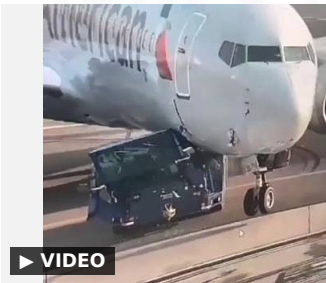
Photo: Supplied by WheelTug

X post, 4 Aug 2022 (same CCTV recording, different edit)  
Still: frame at 36 s from a video as shared with WheelTug. No watermark visible.

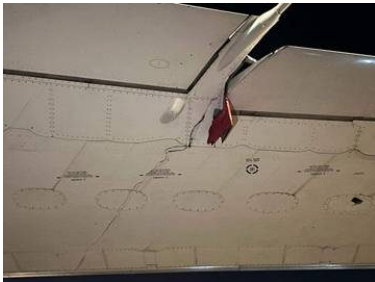
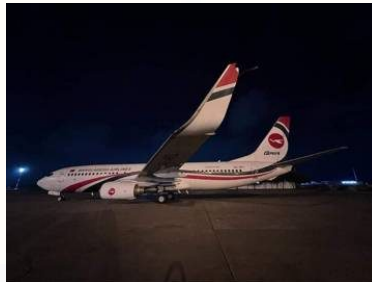
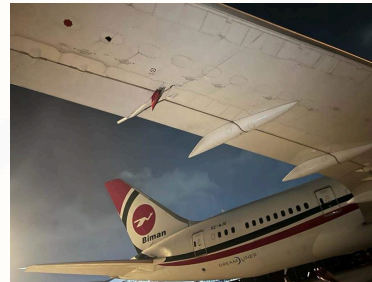
Photo: @muktadimewage on X — [source](#)

Photo: Supplied by WheelTug

**Our assessment (not an investigator finding):** The aircraft was under tow (repositioning, maintenance or gate move) and the towing team misjudged clearance. Where such moves could be done under WheelTug power with a crew on board, the tug and tow bar would be removed and WheelTug Vision would give the operator a camera view of wingtips and tail. Unmanned maintenance tows would likely still use tugs, so relevance is partial.

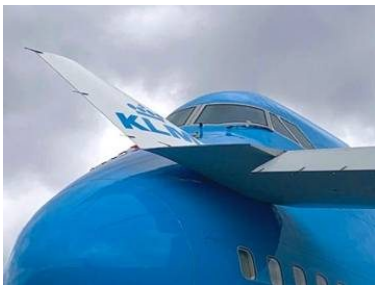
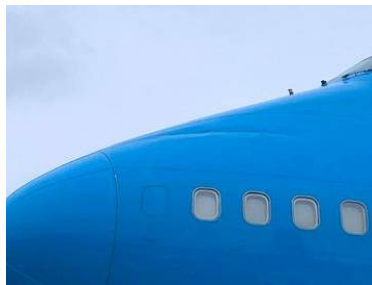
Photo: @MicHighClub on X — [source](#)

**Our assessment (not an investigator finding):** The aircraft was under tow (repositioning, maintenance or gate move) and the towing team misjudged clearance. Where such moves could be done under WheelTug power with a crew on board, the tug and tow bar would be removed and WheelTug Vision would give the operator a camera view of wingtips and tail. Unmanned maintenance tows would likely still use tugs, so relevance is partial.

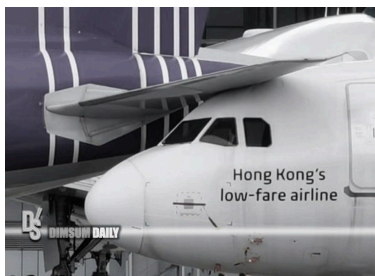
**Our assessment (not an investigator finding):** The aircraft was under tow (repositioning, maintenance or gate move) and the towing team misjudged clearance. Where such moves could be done under WheelTug power with a crew on board, the tug and tow bar would be removed and WheelTug Vision would give the operator a camera view of wingtips and tail. Unmanned maintenance tows would likely still use tugs, so relevance is partial.

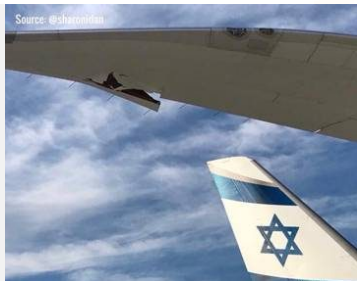
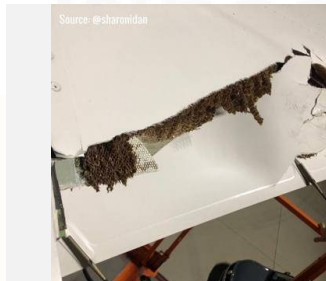
| <b>What happened</b> | El Al flight LY22, a Boeing 787-9, contacted a pole while being towed to a parking spot in Las Vegas. The right-hand rear part of the wing tip sustained cracks. |

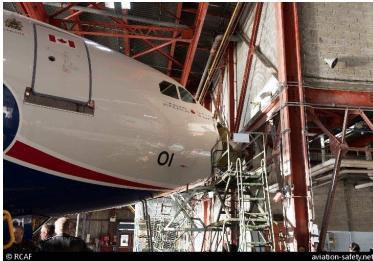
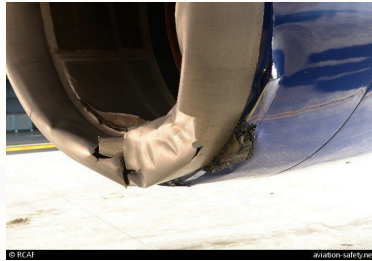
**Our assessment (not an investigator finding):** The aircraft was under tow (repositioning, maintenance or gate move) and the towing team misjudged clearance. Where such moves could be done under WheelTug power with a crew on board, the tug and tow bar would be removed and WheelTug Vision would give the operator a camera view of wingtips and tail. Unmanned maintenance tows would likely still use tugs, so relevance is partial. Business jet / non-airliner: shows the risk type, not a direct WheelTug market case.

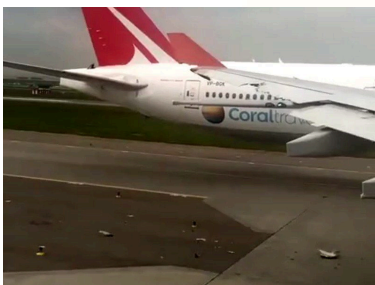
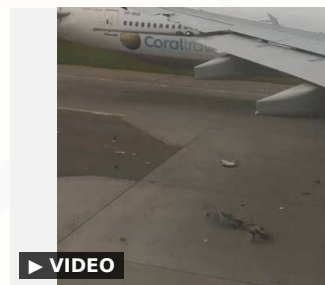
| <b>What happened</b> | An Aeroflot Airbus A330-343 (VQ-BMY) and a Royal Flight Boeing 777 (VP-BGK) sustained minor damage in a ground contact incident at Moscow's Sheremetyevo Airport. As the Royal Flight plane was being towed, the right-hand wing clipped the left-hand wing of the Aeroflot plane. |

**Our assessment (not an investigator finding):** The aircraft was under tow (repositioning, maintenance or gate move) and the towing team misjudged clearance. Where such moves could be done under WheelTug power with a crew on board, the tug and tow bar would be removed and WheelTug Vision would give the operator a camera view of wingtips and tail. Unmanned maintenance tows would likely still use tugs, so relevance is partial.

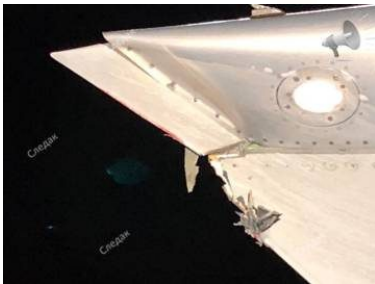
**Our assessment (not an investigator finding):** The aircraft was under tow (repositioning, maintenance or gate move) and the towing team misjudged clearance. Where such moves could be done under WheelTug power with a crew on board, the tug and tow bar would be removed and WheelTug Vision would give the operator a camera view of wingtips and tail. Unmanned maintenance tows would likely still use tugs, so relevance is partial.

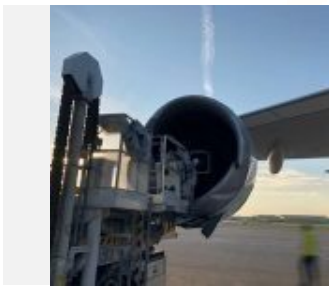
| <b>What happened</b> | The no. 4 engine was substantially damaged when it collided with a high loader while the aircraft was being towed to the Romeo platform at Amsterdam-Schiphol Airport. |

**Our assessment (not an investigator finding):** The aircraft was under tow (repositioning, maintenance or gate move) and the towing team misjudged clearance. Where such moves could be done under WheelTug power with a crew on board, the tug and tow bar would be removed and WheelTug Vision would give the operator a camera view of wingtips and tail. Unmanned maintenance tows would likely still use tugs, so relevance is partial.

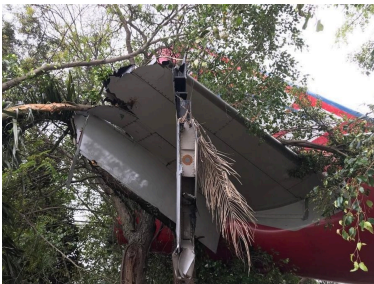
| <b>What happened</b> | An Airbus A320-232 of LATAM Airlines Brasil rolled into trees while being towed at São Paulo-Congonhas Airport in Brazil. The aircraft was being towed when the aircraft apparently rolled to the rear near Apron 3. The tail impacted a group of trees, causing severe damage to the right-hand horizontal stabilizer. |

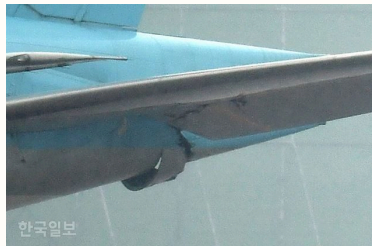
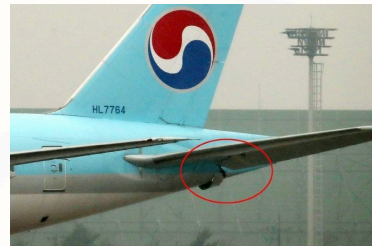
| <b>What happened</b> | A Korean Air Boeing 777-2B5ER, HL7764, sustained substantial damage to the rear underside of the fuselage after being struck by an Asiana Airlines Airbus A330 at Seoul-Gimpo Airport, South Korea. At the time of the incident, the A330, HL8286, was being towed from parking spot 228 to gate 39. At the same time, the Boeing 777 was being towed from parking spot 230 to gate 35. The Boeing 777 had stopped on the apron at the intermediate holding position opposite of gate 35. The A330 was then towed behind it over taxiway N3. The right hand winglet of the Airbus then impacted the horizontal stabilizer and underside of the rear fuselage of the Boeing 777. METAR: 22:38 UTC / 07:38 local time: RKSS 252238Z 12005KT 090V160 2500 RA BR BKN025 OVC080 21/17 Q1008 NOSIG 23:00 UTC / 08:00 local time: RKSS 252300Z 10010KT 2500 RA BR BKN025 OVC080 20/17 Q1007 NOSIG |

**Our assessment (not an investigator finding):** The aircraft was under tow (repositioning, maintenance or gate move) and the towing team misjudged clearance. Where such moves could be done under WheelTug power with a crew on board, the tug and tow bar would be removed and WheelTug Vision would give the operator a camera view of wingtips and tail. Unmanned maintenance tows would likely still use tugs, so relevance is partial.

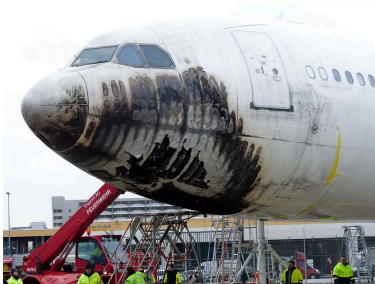
| <b>What happened</b> | An Airbus A340-300, registration D-AIFA, was being towed at Frankfurt Airport, Germany when a fire broke out in the tow tug. The plane sustained substantial damage to the nose and cockpit section. Ten airport staff, consisting of ground crew and emergency responders, suffered minor injuries as a result of smoke inhalation. The aircraft was being prepared for flight LH426 from Frankfurt Airport, Germany to Philadelphia International Airport, USA. D-AIGP was assigned to replace the damaged aircraft, and departed at 3:10PM CEST with a delay of two hours. |

**Our assessment (not an investigator finding):** The aircraft was under tow (repositioning, maintenance or gate move) and the towing team misjudged clearance. Where such moves could be done under WheelTug power with a crew on board, the tug and tow bar would be removed and WheelTug Vision would give the operator a camera view of wingtips and tail. Unmanned maintenance tows would likely still use tugs, so relevance is partial.

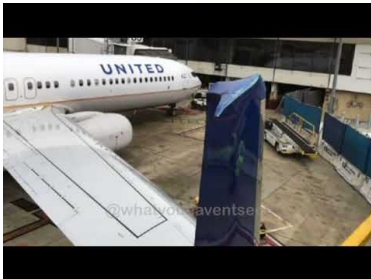
**Our assessment (not an investigator finding):** The aircraft was under tow (repositioning, maintenance or gate move) and the towing team misjudged clearance. Where such moves could be done under WheelTug power with a crew on board, the tug and tow bar would be removed and WheelTug Vision would give the operator a camera view of wingtips and tail. Unmanned maintenance tows would likely still use tugs, so relevance is partial.

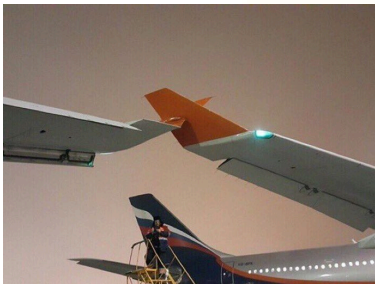
**Our assessment (not an investigator finding):** The aircraft was under tow (repositioning, maintenance or gate move) and the towing team misjudged clearance. Where such moves could be done under WheelTug power with a crew on board, the tug and tow bar would be removed and WheelTug Vision would give the operator a camera view of wingtips and tail. Unmanned maintenance tows would likely still use tugs, so relevance is partial.

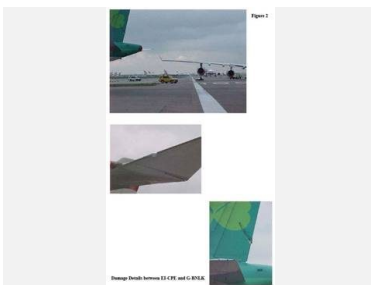
**Our assessment (not an investigator finding):** The 747 was under tow and its wingtip struck a stationary aircraft. A WheelTug-powered move with a crew on board would remove the tug and tow bar, and WheelTug Vision would give a camera view of the wingtip; unmanned maintenance tows would likely still use tugs, so relevance is partial.

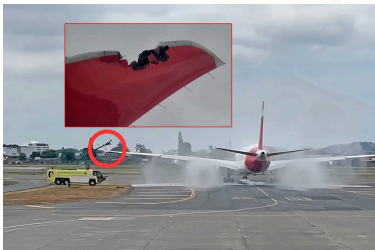
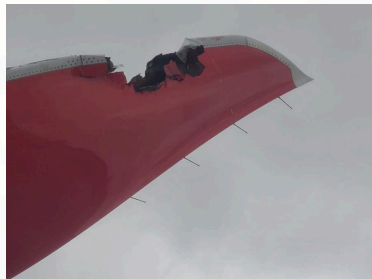
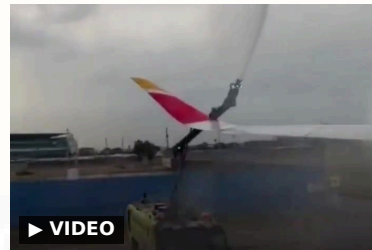
| <b>Note</b> | Filed under ground vehicle driver: AeroTime reports the truck on the left appeared to be positioned too close to the aircraft's path. El Universo quotes two pilots who point to a misjudgement by the fire crew, while also saying the flight crew's actions should be reviewed. |

**Our assessment (not an investigator finding):** The wingtip hit the raised turret of a fire truck parked beside the taxiway. The crew cannot see the A350's wingtip from the flight deck, as a pilot quoted by El Universo notes. WheelTug Vision's wingtip cameras would have shown the crew the clearance to the turret before the wing reached it, so they could stop or ask for the truck to be moved.

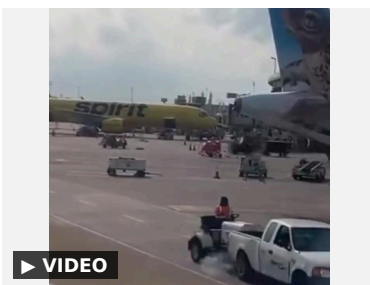
**Our assessment (not an investigator finding):** The truck drove behind an aircraft that was being pushed back. With WheelTug, the crew controls the pushback and WheelTug Vision shows the area behind the aircraft, so the crew could stop for a vehicle crossing behind it.

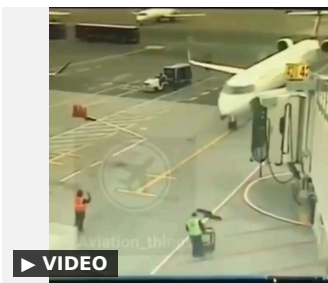
**Our assessment (not an investigator finding):** The baggage train crossed in front of a taxiing aircraft. WheelTug Vision's nose and surroundings cameras show the crew vehicles closing on their path at short range, so they could stop sooner. WheelTug's slow, precise electric taxi near the gates also gives more room to stop.

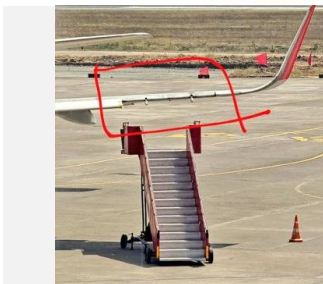
Photo: @shukla\_tarun on X — [source](#)

**Our assessment (not an investigator finding):** A ground vehicle and a moving aircraft came into conflict. WheelTug Vision cameras could show the crew vehicles near the wingtips and nose that are invisible from the cockpit, and low-speed electric taxi gives fine control, but the vehicle driver's behaviour is outside WheelTug's control. Relevance is partial.

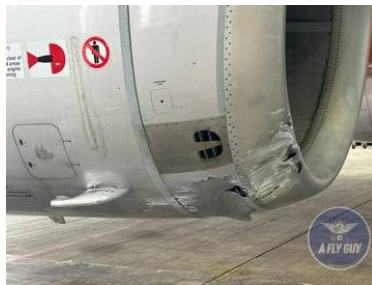
| <b>What happened</b> | The airplane was hit by a utility vehicle and was taken out of service. The no.2 engine nacelle was damaged. |

Photo: @AFlyGuyTravels on X — [source](#)

**Our assessment (not an investigator finding):** A ground vehicle and a moving aircraft came into conflict. WheelTug Vision cameras could show the crew vehicles near the wingtips and nose that are invisible from the cockpit, and low-speed electric taxi gives fine control, but the vehicle driver's behaviour is outside WheelTug's control. Relevance is partial.

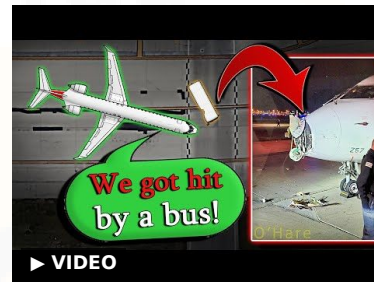
| <b>What happened</b> | An American Airlines regional jet collided with a shuttle bus at Chicago O'Hare Airport while taxiing for T/O. There were no injuries in the airplane. Two people on the bus sustained minor injuries. Aircraft suffered substantial damage to it's nose cone. |

Photo: via CNN (edition.cnn.com) — [source](#)

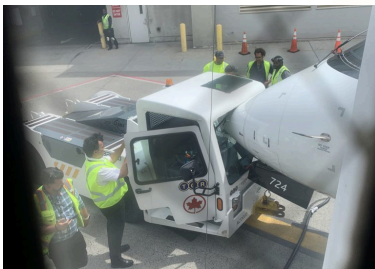
| <b>Damage</b> | Damage visible in the posted photo; extent not stated |
| <b>Note</b> | Date is the JACDEC post date. Source does not make clear whether the aircraft or the tug was moving at impact. |

Photo: @JacdecNew on X — [source](#)

**Our assessment (not an investigator finding):** A ground vehicle and a moving aircraft came into conflict. WheelTug Vision cameras could show the crew vehicles near the wingtips and nose that are invisible from the cockpit, and low-speed electric taxi gives fine control, but the vehicle driver's behaviour is outside WheelTug's control. Relevance is partial.

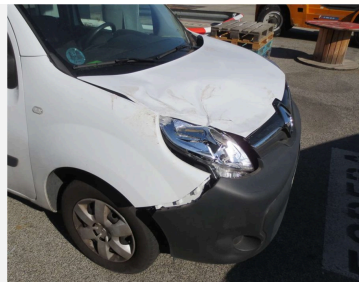
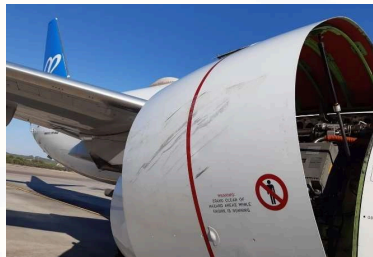
| <b>What happened</b> | Air Europa flight UX6066, a Boeing 737-85P, was taxiing on taxiway M at Madrid Airport, after landing on runway 18L. At a certain point, the crew noticed that a van without a driver was encroaching on the taxiway from the right. The pilot attempted to avoid it by making a left turn, but this was not sufficient. The vehicle impacted the side of engine number 2 and came to rest on the other side of the taxiway. The aircraft continued taxiing without stopping and was able to reach its parking place. There were no injuries. The aircraft sustained damage to the nacelle of engine number 2. The aircraft was repaired and resumed service 25 August 2021. Causes/contributing factors The investigation has determined that the cause of the incident was the failure of the van driver to adhere to platform safety regulations by not activating the handbrake before leaving his vehicle. |

Photo: CIAIAC (official investigation report) — [source](#)

**Our assessment (not an investigator finding):** A ground vehicle and a moving aircraft came into conflict. WheelTug Vision cameras could show the crew vehicles near the wingtips and nose that are invisible from the cockpit, and low-speed electric taxi gives fine control, but the vehicle driver's behaviour is outside WheelTug's control. Relevance is partial.

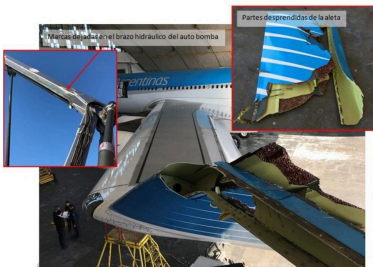
Photo: Junta de Investigación de Accidentes de Aviación Civil, via Aviation Safety Network — [source](#)

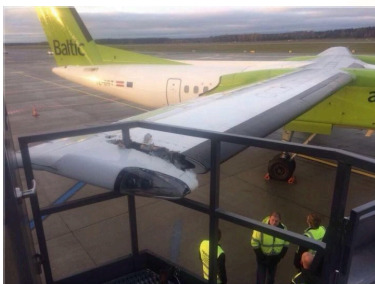
Photo, via @JacdecNew on X — [source](#)

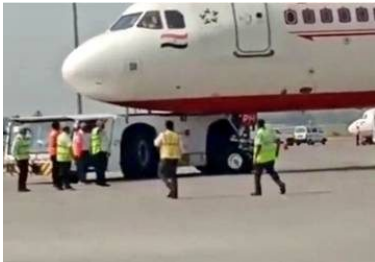
Photo: @shukla\_tarun on X — [source](#)

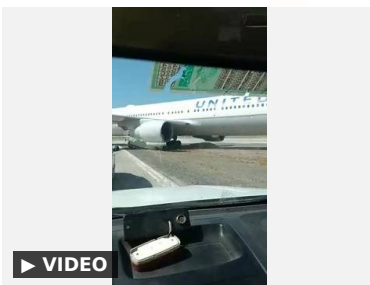
| <b>Official investigation</b> | No public investigation report found. Cause of the separation not published. |

X post, 24 Dec 2021 (45.0 s, same footage; "SCL Airport")

Still: frame from the video in the linked post (same footage).

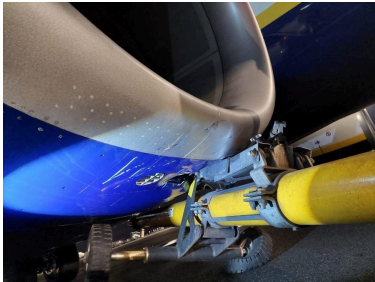
| <b>Note</b> | Tow bar not removed before taxi (how this happened was not published). |

Photo: Supplied by WheelTug; original: Vimeo  
— [source](#)

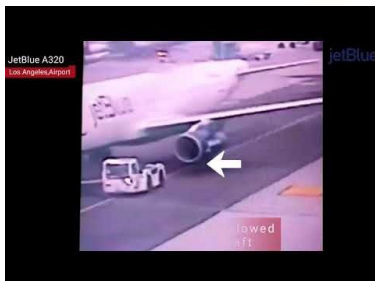
Still: YouTube video "JetBlue A320 Plane Runs Over TUG @Los Angels International Airport | Incident", via TourismTripp (auto-frame) — [source](#)

**Our assessment (not an investigator finding):** A tow bar failure needs a tow bar. Under WheelTug power the aircraft pushes back on its own nose-wheel motors with no tow bar or tug attached, so this specific failure mode would not exist on a WheelTug-powered pushback. Tow bars would still be used for tows with an inop APU and no active engine.

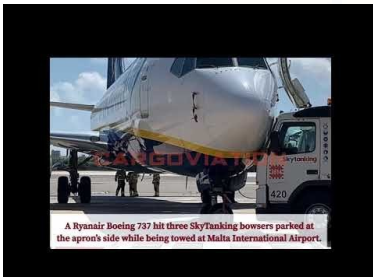
Still: YouTube video "RYANAIR B737 Hits| Malta Airport | cargoviation", via Cargoviation (auto-frame) — [source](#)

**Our assessment (not an investigator finding):** A tow bar failure needs a tow bar. Under WheelTug power the aircraft pushes back on its own nose-wheel motors with no tow bar or tug attached, so this specific failure mode would not exist on a WheelTug-powered pushback. Tow bars would still be used for tows with an inop APU and no active engine.

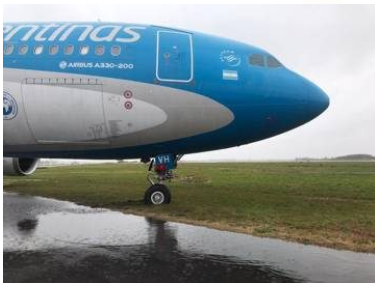
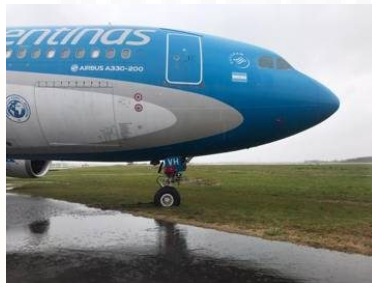
Photo: @AlertasTransito on X — [source](#)

**Our assessment (not an investigator finding):** A tow bar failure needs a tow bar. Under WheelTug power the aircraft pushes back on its own nose-wheel motors with no tow bar or tug attached, so this specific failure mode would not exist on a WheelTug-powered pushback. Tow bars would still be used for tows with an inop APU and no active engine.

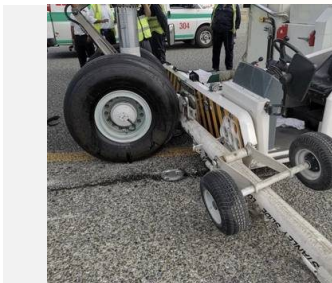
Photo: @PlanesOfLegend on X — [source](#)

**Our assessment (not an investigator finding):** A tow bar failure needs a tow bar. Under WheelTug power the aircraft pushes back on its own nose-wheel motors with no tow bar or tug attached, so this specific failure mode would not exist on a WheelTug-powered pushback. Tow bars would still be used for tows with an inop APU and no active engine.

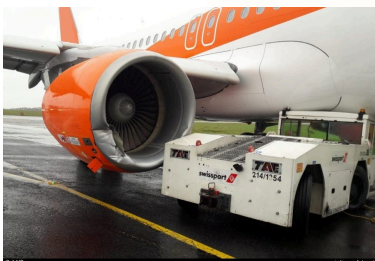
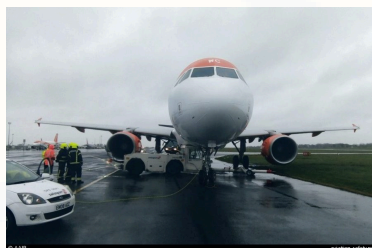
Photo: AAIB, via Aviation Safety Network — [source](#)

**Our assessment (not an investigator finding):** A tow bar failure needs a tow bar. Under WheelTug power the aircraft pushes back on its own nose-wheel motors with no tow bar or tug attached, so this specific failure mode would not exist on a WheelTug-powered pushback. Tow bars would still be used for tows with an inop APU and no active engine.

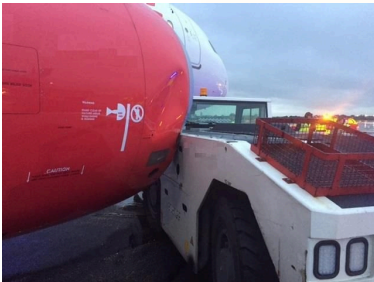
| <b>What happened</b> | Iberia Express flight 3791, an Airbus A320-216, sustained damage to the no.2 engine air inlet cowl after contacting a tow truck at Dublin Airport, Ireland. Having obtained Air Traffic Control approval "to push and start to Tug Release Point November [TRP 'N']", Airbus A320 EC- LVQ was pushed off parking Stand 318R, in preparation for departure to Madrid Barajas Airport (LEMD), Spain. The manoeuvre involved an initial pushback, followed by a pull forward onto Apron Taxiway 5, to TRP 'N'. Following the initial pushback, and in order to bring the aircraft onto the taxiway, the tractor pulled the aircraft forward through the taxiway centreline to the south east of the line, prior to turning right to align the aircraft with the taxiway. During the pull forward the flight crew obtained clearance from the headset operator to start the starboard engine. As the tractor turned right to align the aircraft onto the taxiway, the aircraft nose began to overtake the tractor. The headset operator immediately instructed the Flight Crew to shut down the starboard engine. Although the tractor driver attempted to stop the tractor, it was pulled and rotated as the aircraft continued to move forward. The aircraft then turned slightly to the right as it remained attached to the tractor via the towbar and came to rest with the tractor wedged against the right hand side of the starboard engine cowling. Probable Cause: Failure of the towbar shear- pin during a pull forward manoeuvre. |

Photo: AAIU, via Aviation Safety Network — source

**Our assessment (not an investigator finding):** A tow bar failure needs a tow bar. Under WheelTug power the aircraft pushes back on its own nose-wheel motors with no tow bar or tug attached, so this specific failure mode would not exist on a WheelTug-powered pushback. Tow bars would still be used for tows with an inop APU and no active engine.

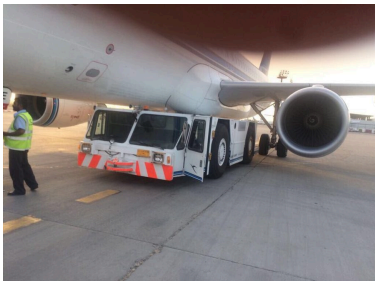
| <b>What happened</b> | A Kuwait Airways Airbus A320 was damaged after it hit a push-back tractor at Kuwait International Airport. The aircraft was being pushed back from the gate for flight KU331 to Thiruvananthapuram in India when the incident happened. The tow bar broke, causing the vehicle to become stuck under the fuselage. |

Photo, via @crashaerien on X — [source](#)

**Our assessment (not an investigator finding):** A tow bar failure needs a tow bar. Under WheelTug power the aircraft pushes back on its own nose-wheel motors with no tow bar or tug attached, so this specific failure mode would not exist on a WheelTug-powered pushback. Tow bars would still be used for tows with an inop APU and no active engine.

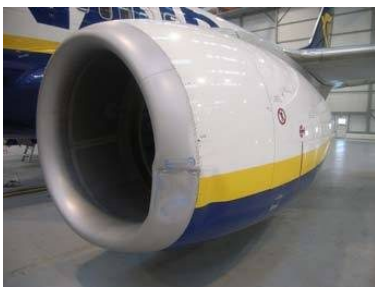
| <b>What happened</b> | A cross-bleed engine start was made during pushback. The towbar failed and the engine struck the tug. |

Photo: UK AAIB report — [source](#)

**Our assessment (not an investigator finding):** A tow bar failure needs a tow bar. Under WheelTug power the aircraft pushes back on its own nose-wheel motors with no tow bar or tug attached, so this specific failure mode would not exist on a WheelTug-powered pushback. Tow bars would still be used for tows with an inop APU and no active engine.

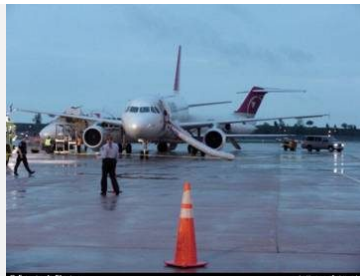
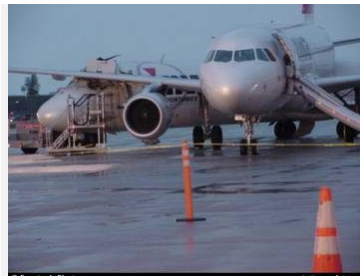
| <b>What happened</b> | After a hydraulic failure, with the left engine shut down by the captain, the taxiing NW DC-9 N763NC struck NW A319 N368NB. Passengers evacuated the A319 by slide. |

Photo © FonziesAvPhotos, via Aviation Safety Network — [source](#)

**Our assessment (not an investigator finding):** WheelTug drive motors can slow the aircraft but do not replace the aircraft's brakes, which still depend on its hydraulics. The benefit here is limited and uncertain.

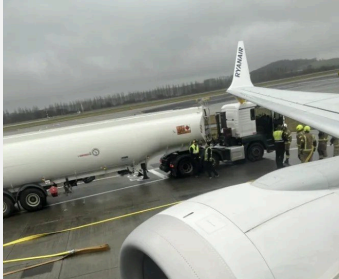
| GC-0492 · 2025-12-22 · Edinburgh-Turnhouse Airport (EDI/EGPH) - United Kingdom | |
|---|---|
| <div> </div> <p>Photo: via uknip.co.uk (uknip.co.uk) — source <a href="https://uknip.co.uk/news/uk/breaking/chaos-at-edinburgh-airport-plane-crashes-into-fuel-truck/">https://uknip.co.uk/news/uk/breaking/chaos-at-edinburgh-airport-plane-crashes-into-fuel-truck/</a></p> <p>Video posted on X by @STVNews (2025-12-22)<br/>Still: X video preview frame, @STVNews on X</p> | |

| GC-0492 · 2025-12-22 · Edinburgh-Turnhouse Airport (EDI/EGPH) - United Kingdom | |
|---|---|
| <p><b>Our assessment (not an investigator finding):</b> This ground event is related to WheelTug's operating area. WheelTug's relevance depends on whether a tug, engine power on the apron, or the crew's limited view was involved; see the description.</p> | |

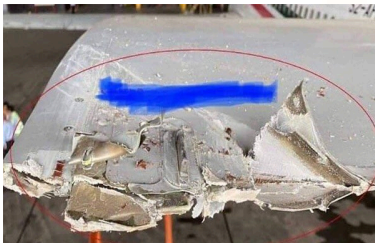
Photo, via @JacdecNew on X (match confidence: medium) — [source](#)

**Our assessment (not an investigator finding):** This ground event is related to WheelTug's operating area. WheelTug's relevance depends on whether a tug, engine power on the apron, or the crew's limited view was involved; see the description.

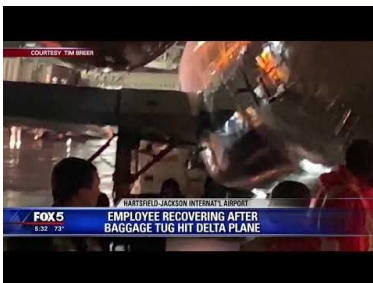
Still: YouTube video "Employee recovering after baggage tug hit Delta plane", via FOX 5 Atlanta (auto-frame) (match confidence: medium) — [source](#)

**Our assessment (not an investigator finding):** The injury happened during pushback or towing, at the nose gear and tug, where headset operators and tug drivers work. A WheelTug pushback has no tug or tow bar and no person needed beside the nose wheel, removing this exposure.

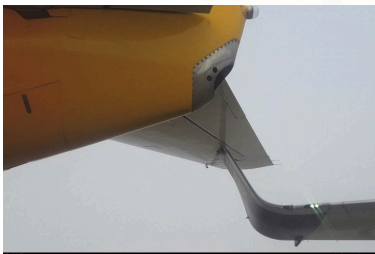
Photo: AAIIB, via Aviation Safety Network — source

**Our assessment (not an investigator finding):** Darkness, weather or low visibility contributed. WheelTug Vision cameras (wingtips, nose gear, surroundings) are aimed at exactly this visibility gap; the electric drive itself is secondary here.

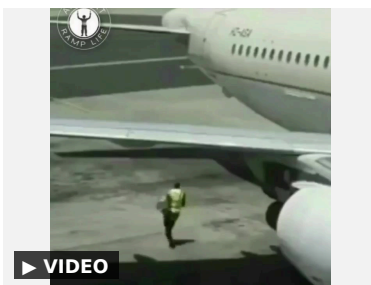
| <b>Note</b> | Event not identified from public sources; the clip is at 0:45 in a ramp-incident montage posted 4 Oct 2025. |

Ramp-incident montage, clip at 0:45  
Still: frame at 0:45. As shared with WheelTug  
(LinkedIn montage, A. G. Giordano)

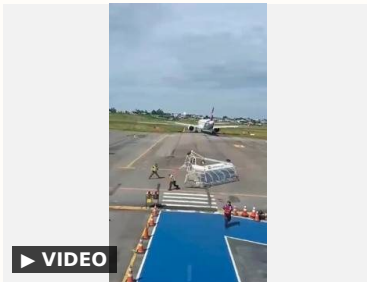
| <b>Damage</b> | Boarding-stair truck toppled; aircraft not damaged (none reported) |

X: @aviationbrk, 16 Jan 2024 (24.9 s, same footage)  
Still: frame from the video in the linked post (same footage). The X copy credits the video to "fdpamplona".

**Our assessment (not an investigator finding):** Jet blast on the apron or taxiway comes from engines running at idle or breakaway thrust near people, equipment and other aircraft. WheelTug's concept is to taxi and manoeuvre on the apron with main engines off, which would remove the exhaust source in exactly these areas; engines would be started away from the gate. Benefit depends on airline procedures for engine start/shutdown location.

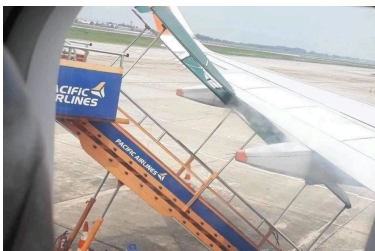
| <b>What happened</b> | Jet blast from a taxiing Antonov An-124 pushed a hand-pushed boarding stair into the wing of the Pacific Airlines A320 parked on stand 56. The wing skin was slightly damaged and the aircraft was withdrawn for repair. |
| <b>Damage</b> | Minor wing-skin damage. |

**Our assessment (not an investigator finding):** Our assessment: jet blast from a taxiing aircraft moved ground equipment into a parked aircraft. Taxiing on WheelTug with main engines off removes the jet blast near stands.

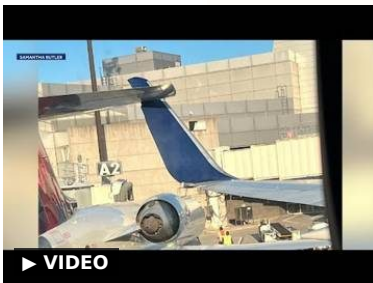
YouTube: Delta plane clips wing of another plane leaving Logan Airport (WCVB Channel 5 Boston)  
Still: YouTube thumbnail, WCVB Channel 5 Boston

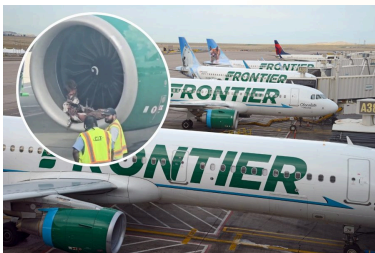
| <b>What happened</b> | A Frontier Airbus A320-251N, flight F93134, ingested a ground air- conditioning hose in engine no.1 while preparing for departure at the gate at Charlotte-Douglas International Airport (CLT/KCLT), Charlotte, North Carolina. The aircraft was taken out of service. |

**Our assessment (not an investigator finding):** Ground air-conditioning hoses, jet bridges and ramp staff are at the stand. When an aircraft arrives or leaves under engine power, they are in the intake's reach. With WheelTug, the aircraft taxis and moves on and off the stand with its main engines off, so there is no engine suction during that time and nothing can be ingested while taxiing. Engines still need a warm-up run before takeoff and a cool-down after landing, so the exposure is reduced, not removed.

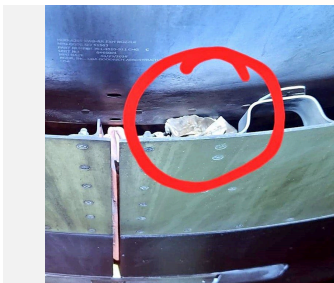
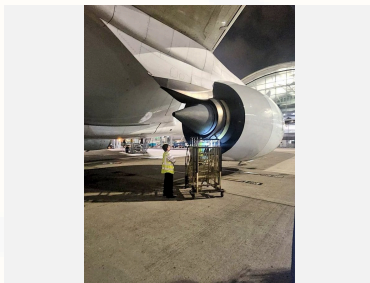
| <b>Note</b> | The worker's Facebook post (later deleted) says the objects were "left in the engine"; no source says how they got there. Moved from the exclusions list into the FOD section on 29 Oct 2026. |

**Our assessment (not an investigator finding):** No source says how the debris got into the engine. In our view it was most likely ingested while the aircraft taxied under engine power. With WheelTug, the aircraft taxis with its main engines off, so nothing can be ingested while taxiing.

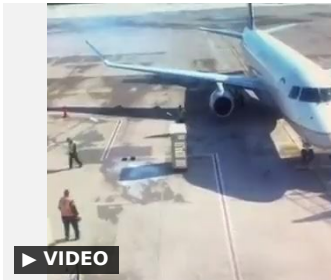
**traffic\_cone** (34.0 s). An Embraer E-Jet at a gate with an engine running. A ground worker carrying red cones walks near the left engine, and a puff appears at the engine about 10-12 s in. The file name suggests a cone was ingested; this cannot be confirmed from the frames.  
Still: frame at 21 s, as shared with WheelTug.  
TikTok watermark "@upnorthwisconsinmike".

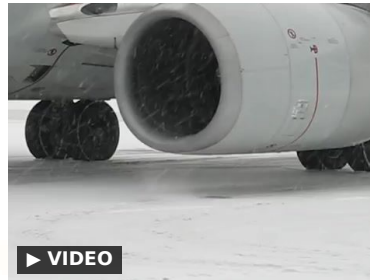
**American Airlines ICE\_FOD\_Vortex** (117.9 s). An American Airlines 737 taxiing in falling snow, with a marshaller; close-ups show snow being drawn into the engine inlet. The frames do not show damage or a compressor stall.  
Still: frame at 90 s, as shared with WheelTug.  
No watermark visible.
